**81133A-01**

# **S E R V I C E                      N O T E**

## 81133A- High Speed Pulse Generator

Serial Numbers: DE42800001-DE42800314

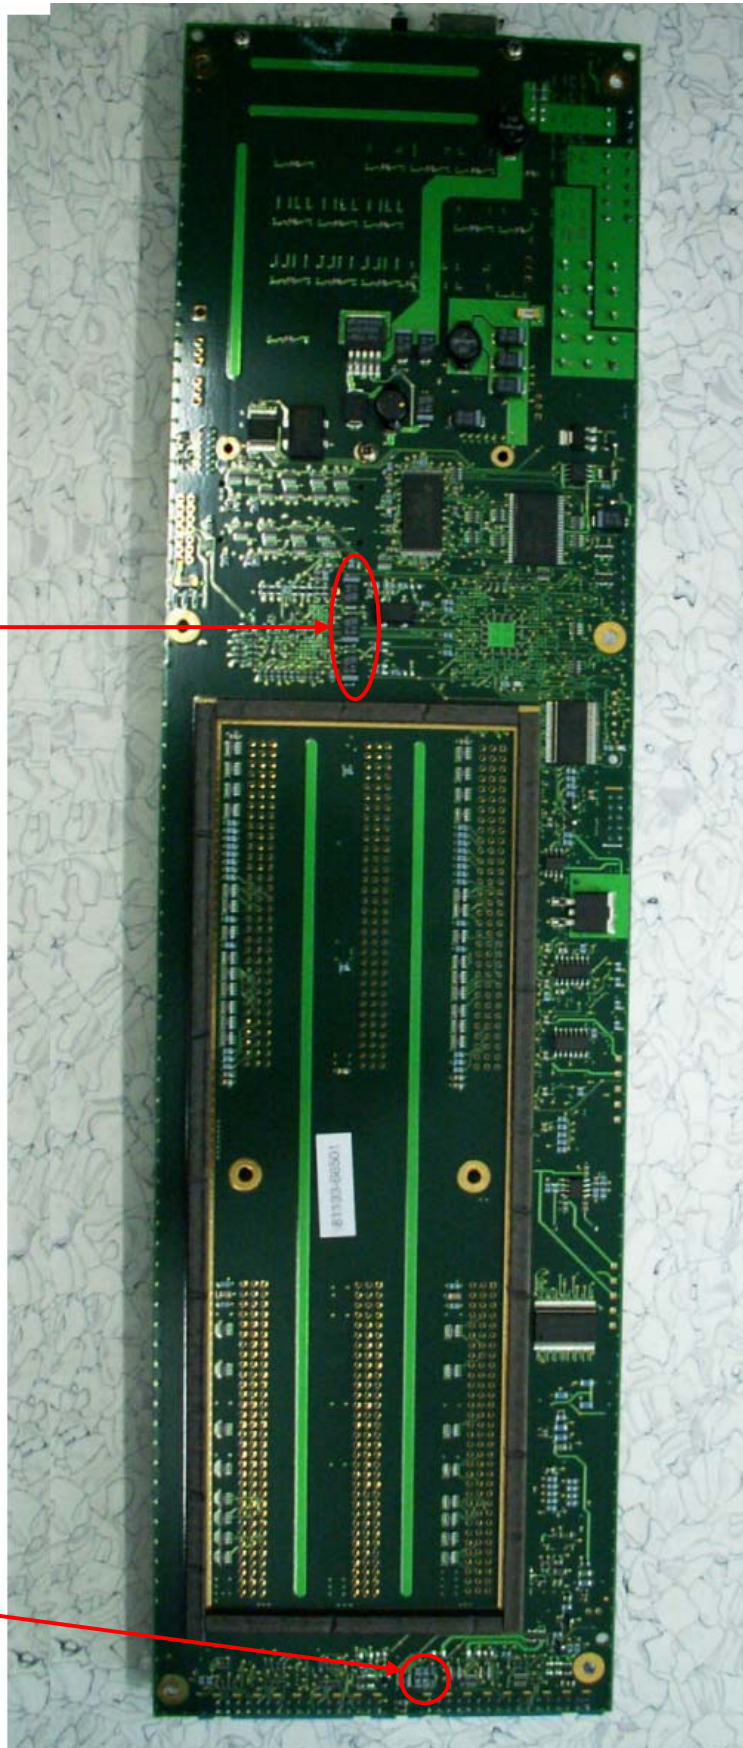
MOTHERBOARD  
BACK SIDE VIEW

Polarized Capacitors

Extra Resistors

The preventive maintenance to avoid flickering display failures requires removing the 3 capacitors shown in the following picture and replacing them with new capacitors (part number 0180-4758) while mounting them with the correct polarity.

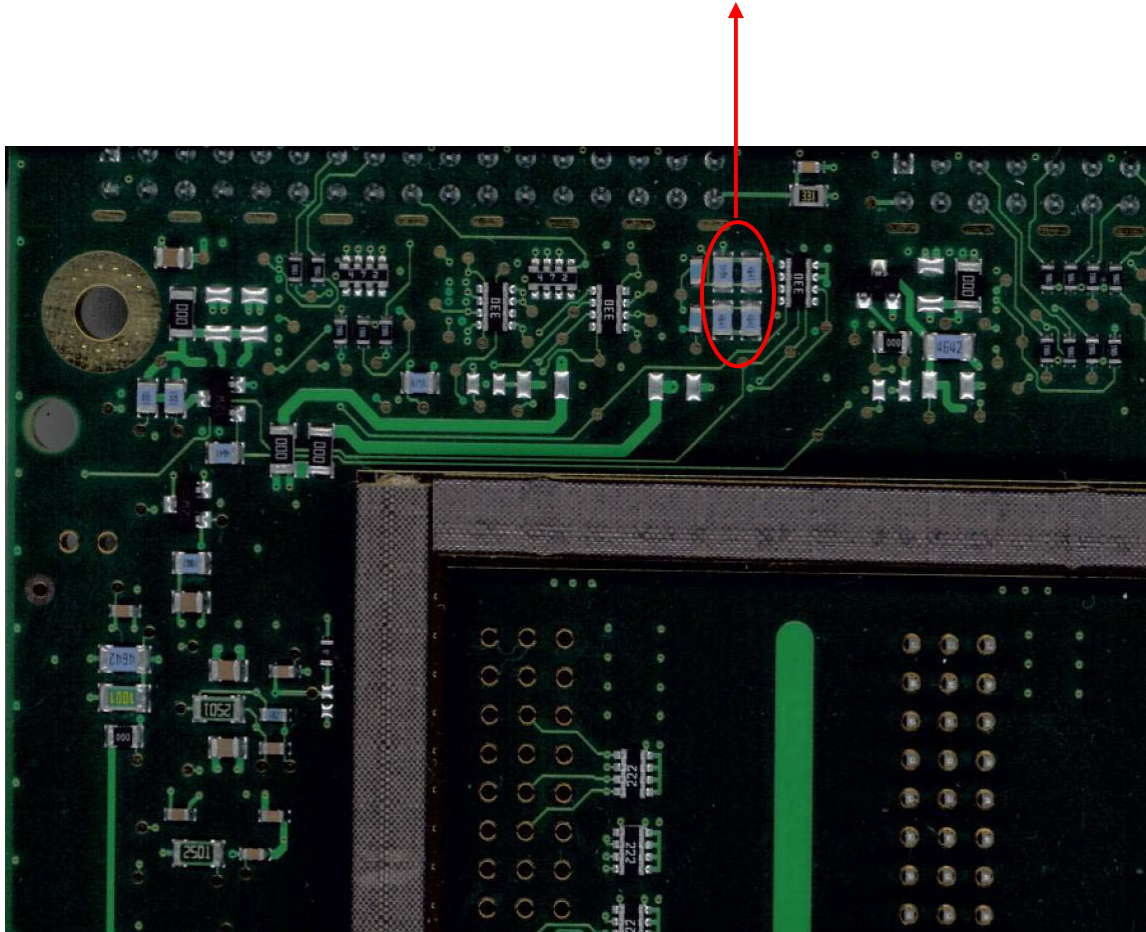
The rotary encoder (APN 0960-1055) has failed in some cases due to incorrect pull up resistance of the encoder. The pull-up resistance of this encoder as specified by the manufacturer is minimum 2.2 K Ohms. According to the schematic of the front panel in the 81133A, the pull-up resistance used was 1.5 K Ohms. The lesser resistance value had possibly led to the flow of more currents into the encoder and had degraded the performance of it over a period of time.

Resistors to be removed ( The colours can be different)

By removing a few parallel resistors the resistance can be increased, preventing failures of the rotary encoder in the future.

For the preventive maintenance of the know problem the following 4 resistors need to be removed. They are best removed using hot air.
