81134A-01

# S E R V I C E                      N O T E

## 81134A- High Speed Pulse Generator

Serial Numbers: DE42800001-DE42800854

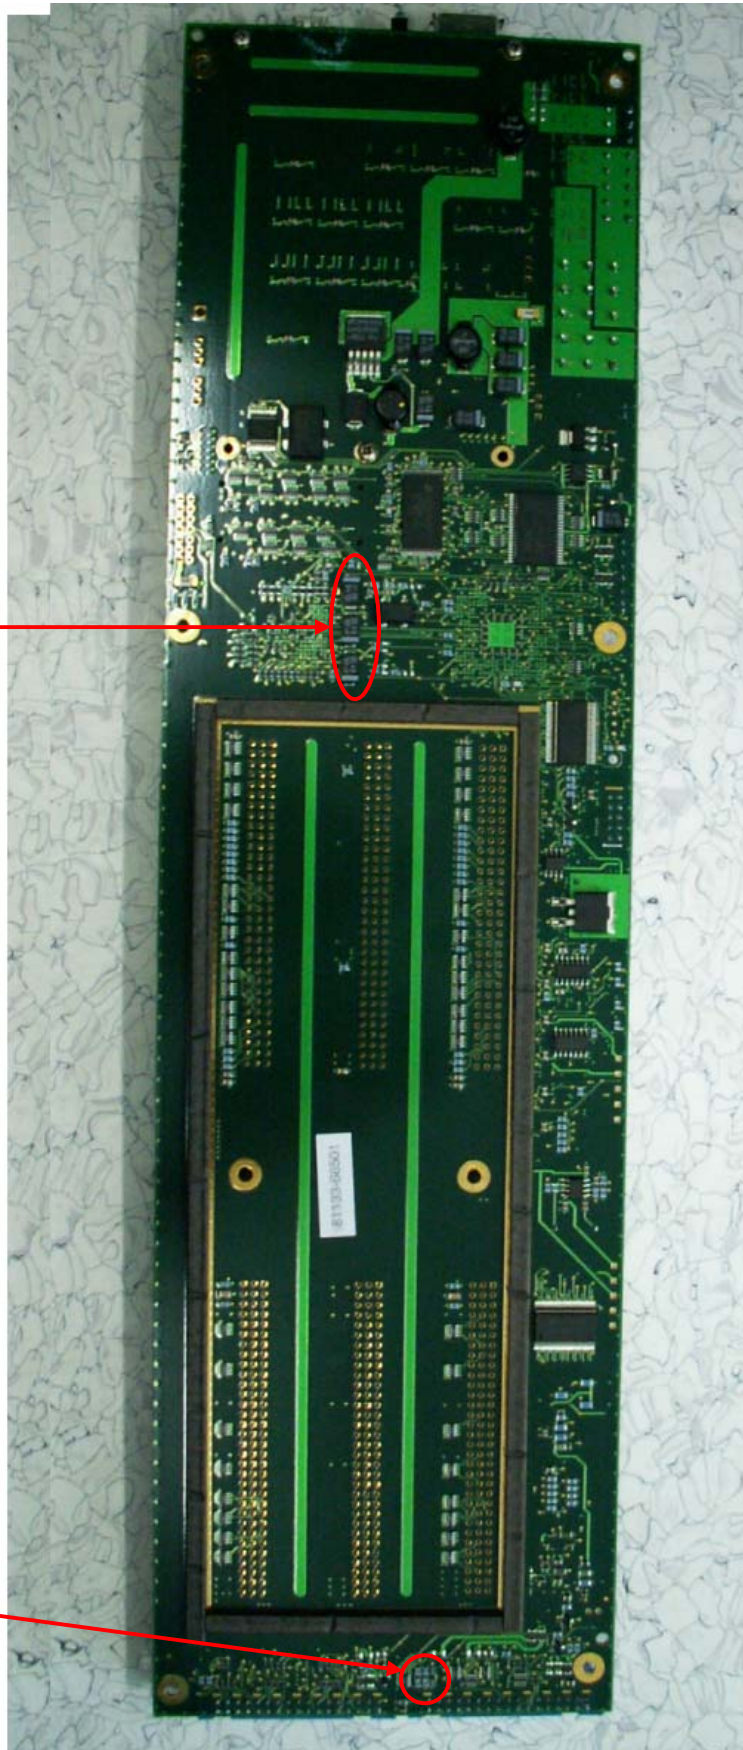
MOTHERBOARD  
BACK SIDE VIEW

Polarized Capacitors

Extra Resistors

The preventive maintenance to avoid flickering display failures requires removing the 3 capacitors shown in the following picture and replacing them with new capacitors (part number 0180-4758) while mounting them with the correct polarity.

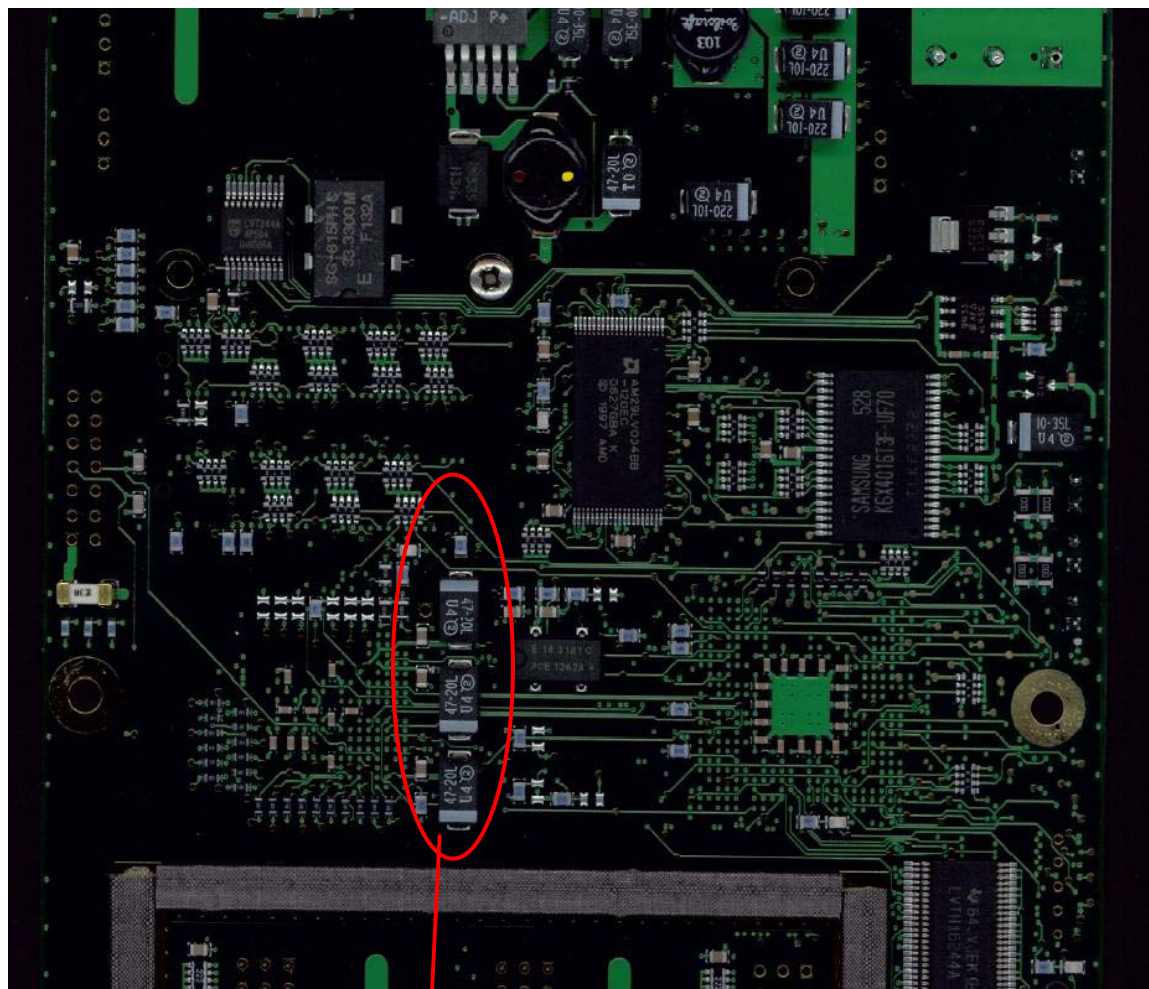
## CLOSE UP VIEW WHERE THE CAPACITORS ARE LOCATED

Three polarized tantalum capacitors on the motherboard are connected with the wrong polarity. The polarized tantalum capacitors are normally more sensitive than others, so they tend to fail after some months. Due to this, wrong voltages were delivered to the front panel board which in turn affected the display.

Capacitors mounted with the wrong polarity. The positive side is shown with the white/grey stripe. These 3 capacitors need to be removed.

The capacitors are best removed using hot air. The new capacitors need to be mounted using standard soldering equipment.

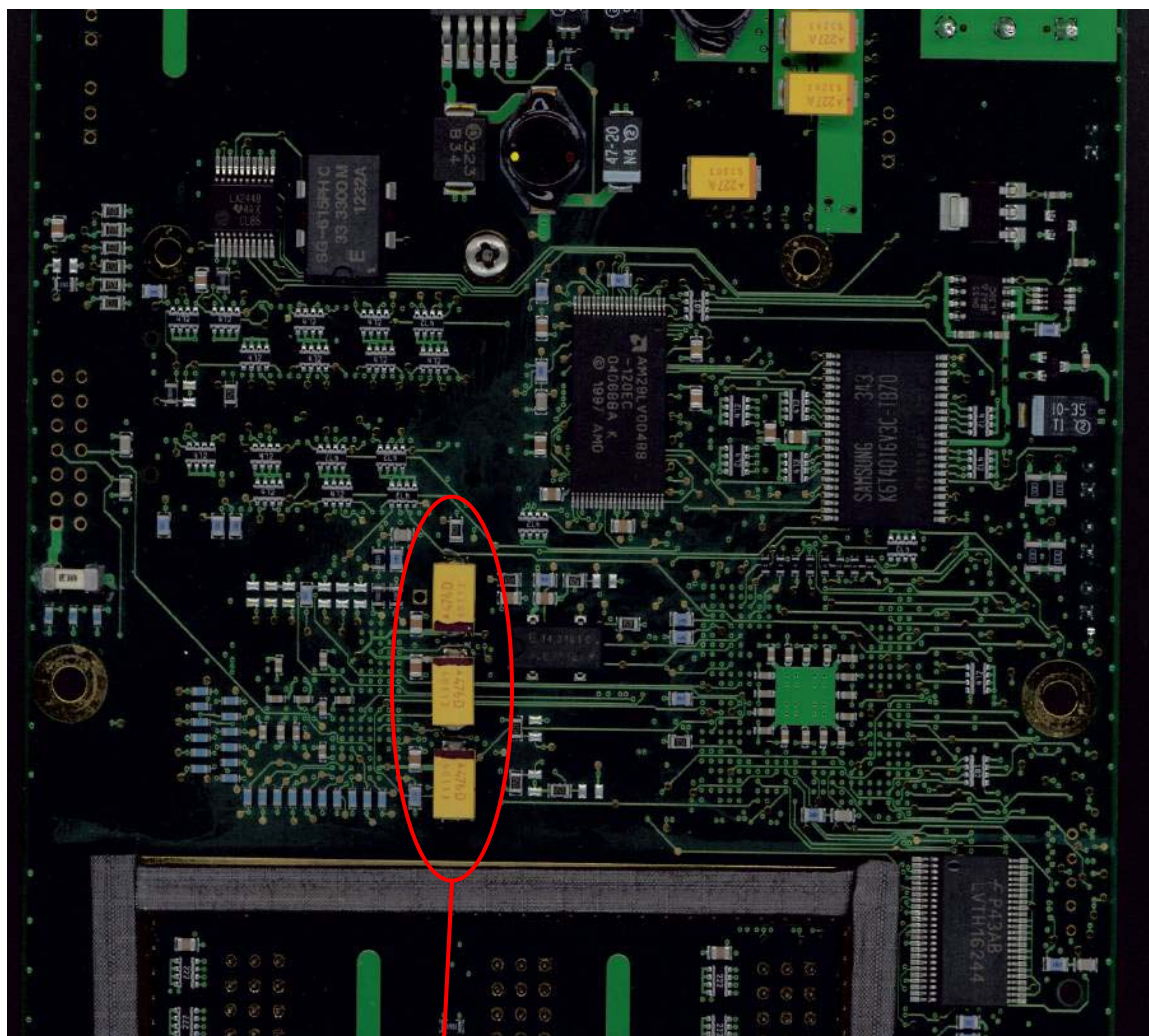
## CLOSE UP VIEW WHERE THE CAPACITORS ARE LOCATED

This photo shows the capacitors mounted with the right polarity. The positive side is shown with the black stripe. The colors might vary.

By applying new capacitors and mounting them with the right polarity failures can be prevented for the future.

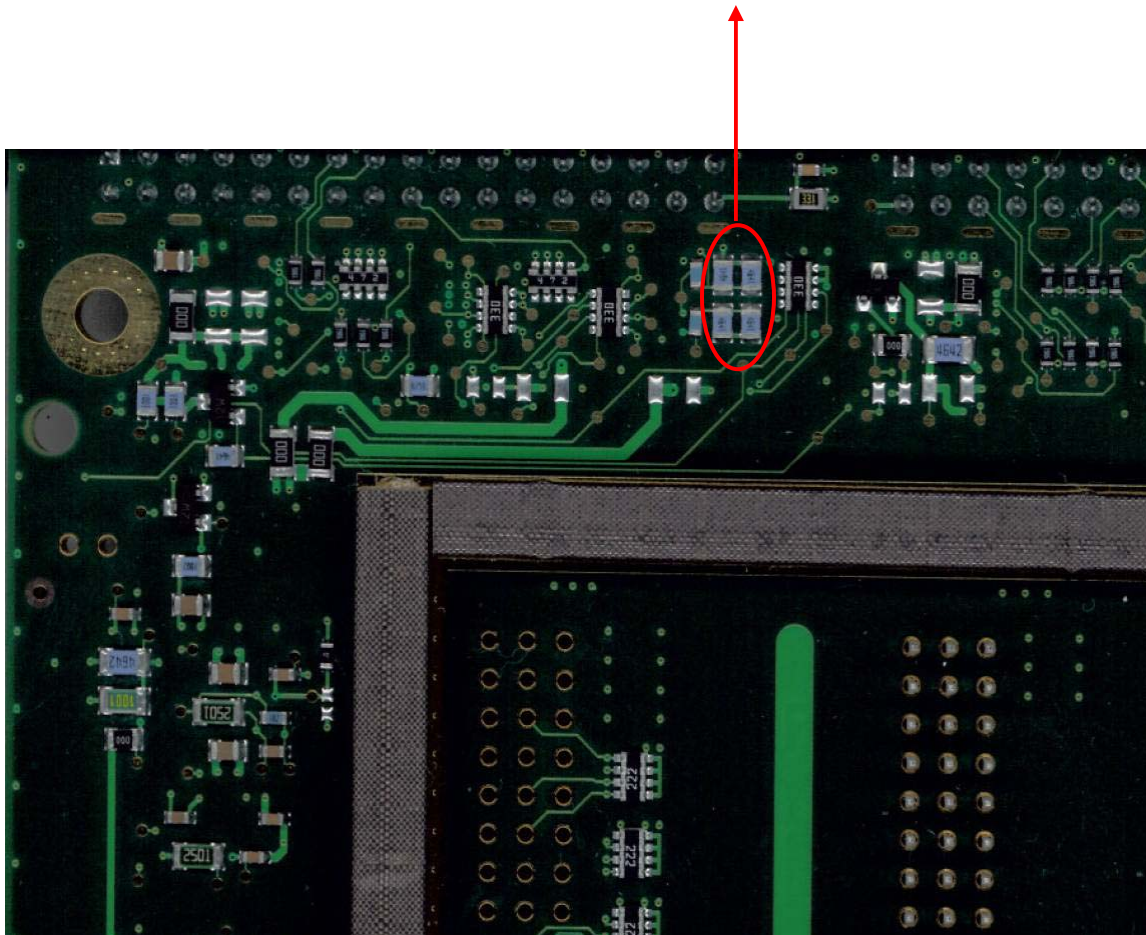
The rotary encoder (APN 0960-1055) has failed in some cases due to incorrect pull up resistance of the encoder. The pull-up resistance of this encoder as specified by the manufacturer is minimum 2.2 K Ohms. According to the schematic of the front panel in the 81134A, the pull-up resistance used was 1.5 K Ohms. The lesser resistance value had possibly led to the flow of more currents into the encoder and had degraded the performance of it over a period of time.

Resistors to be removed ( The colours can be different)

By removing a few parallel resistors the resistance can be increased, preventing failures of the rotary encoder in the future.

For the preventive maintenance of the know problem the following 4 resistors need to be removed. They are best removed using hot air.

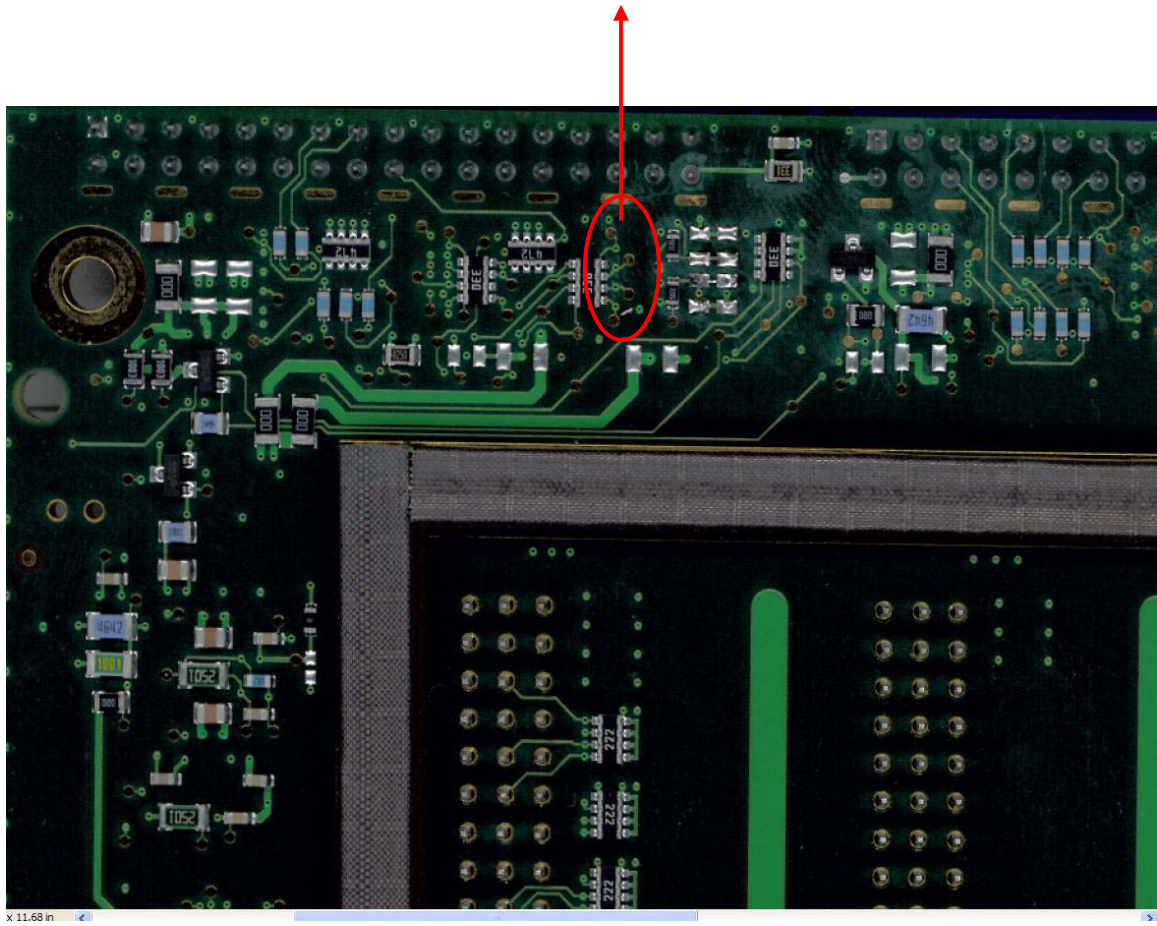
CLOSE UP VIEW – THE RESISTORS ARE REMOVED

The place where the 4 resistors are removed
