**81141A-01-S**

**S E R V I C E N O T E**

**Product Number: 81141A, High Speed Pulse Generator**

**POSSIBLE FIRE HAZARD**

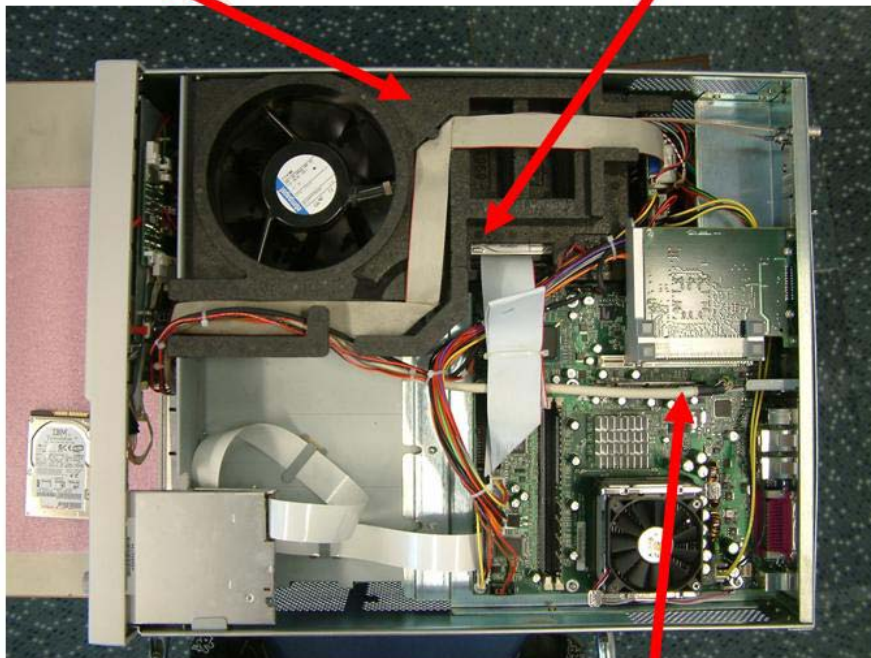
A surface-mount ceramic capacitor suffered physical stress during the manufacturing process, leading the capacitor to crack. During operation this crack placed stress on the internal structure of the capacitor, and caused the plates to short together. (The plates are separated by very little space, made up of very thin insulators.) This caused the capacitor to have very low residual impedance, resulting in a very high current conducted through the capacitor and the 12V path on the motherboard for some period of time. The low impedance didn't lead to a current high enough for blowing the fuse. Therefore the higher current was available long enough to create a very high temperature ( $T > 300^{\circ}\text{C}$ ). The high temperature ignited the polyurethane molding used to conduct the airflow for cooling through the instrument.

The following photo illustrates the layout of the instrument. It shows the polypropylene molding, the graphics card and the starting point of the fire.

**Polypropylene Molding****Start of Fire**

**Graphics Card**

The countermeasure for this issue is to exchange the graphics cards. The new graphics cards are produced with an improved manufacturing process eliminating the risk of micro cracks and have additional fusing to protect the 12V path. The graphics card can be exchanged by Agilent authorized personnel only.

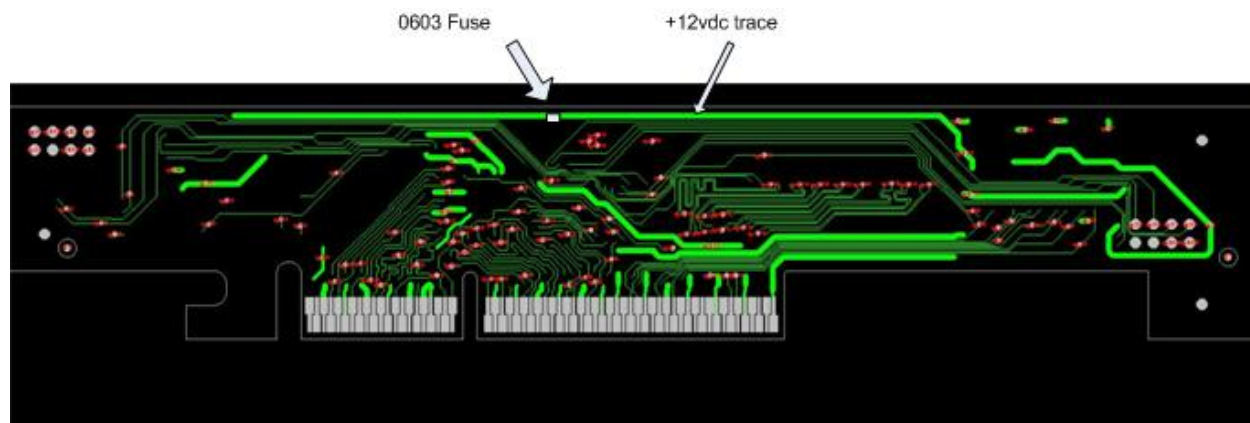
The following picture shows the graphics card with the added fuse:
