81142A-01A-S

S E R V I C E N O T E

81142A – High Speed Pulse Generator

POSSIBLE FIRE HAZARD

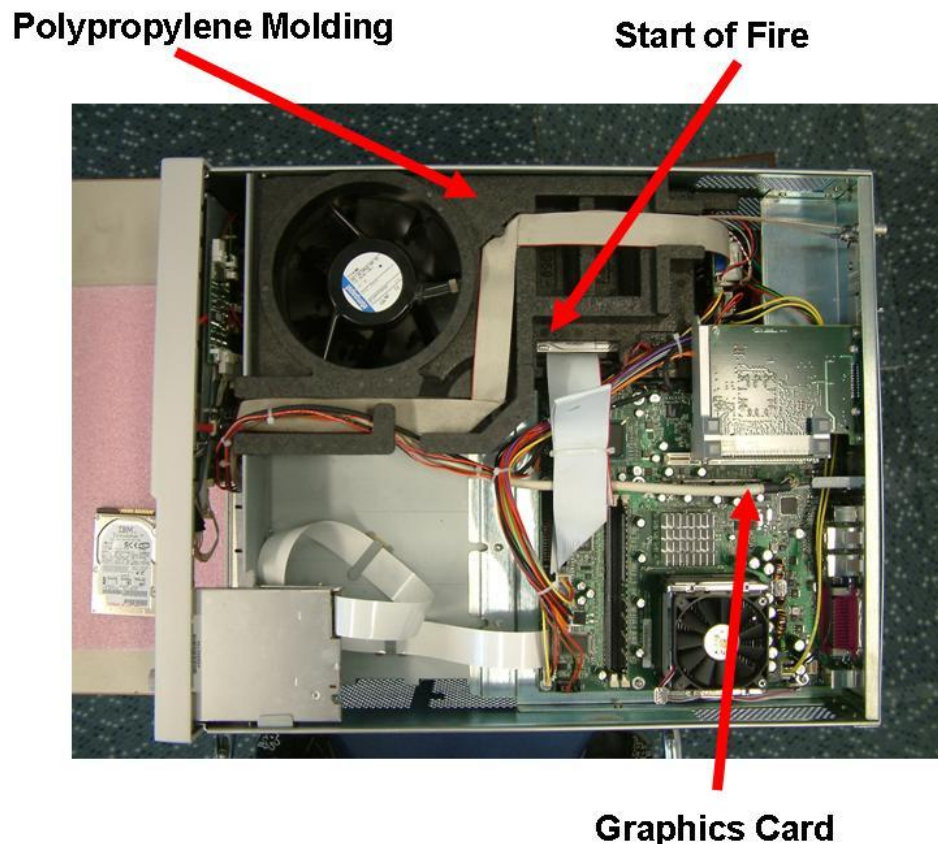
A surface-mount ceramic capacitor suffered physical stress during the manufacturing process, leading the capacitor to crack. During operation this crack placed stress on the internal structure of the capacitor, and caused the plates to short together. (The plates are separated by very little space, made up of very thin insulators.) This caused the capacitor to have very low residual impedance, resulting in a very high current conducted through the capacitor and the 12V path on the motherboard for some period of time. The low impedance didn't lead to a current high enough for blowing the fuse. Therefore the higher current was available long enough to create a very high temperature ($T > 300^{\circ}\text{C}$). The high temperature ignited the polyurethane molding used to conduct the airflow for cooling through the instrument.

The following photo illustrates the layout of the instrument. It shows the polypropylene molding, the graphics card and the starting point of the fire.

The countermeasure for this issue is to exchange the graphics cards. The new graphics cards are produced with an improved manufacturing process eliminating the risk of micro cracks. They either have an additional fusing to protect the 12V path or they have eliminated the 12V path altogether. The graphics card can be exchanged by Agilent authorized personnel only.

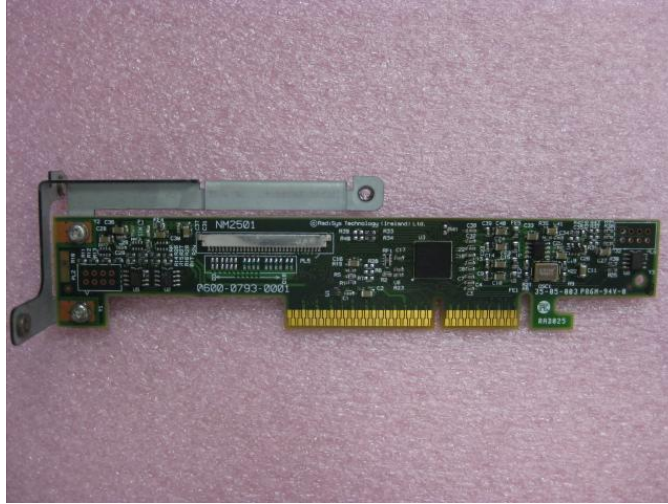
The concerned part is the graphic board: N4901-66577 (exchange part: N4901-69577):

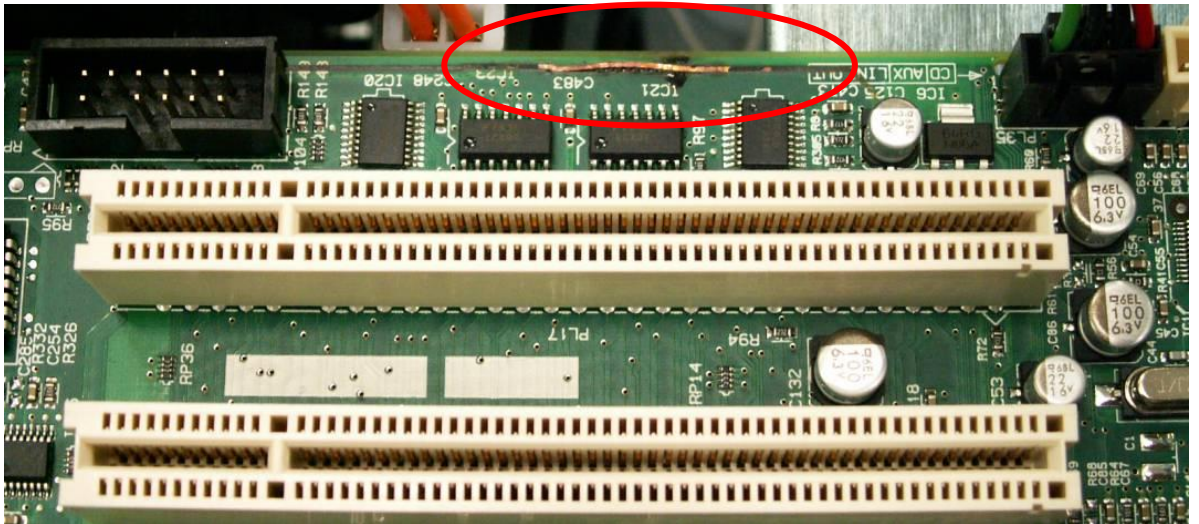
In very exceptional cases if you see traces of smoke or fire, the motherboard needs to be exchanged. In these cases typically the integrated display of the instrument would not work anymore. The exchange of the motherboards can only be done in the Service Center - onsite repair is not possible.

Motherboard considered being bad – please exchange:

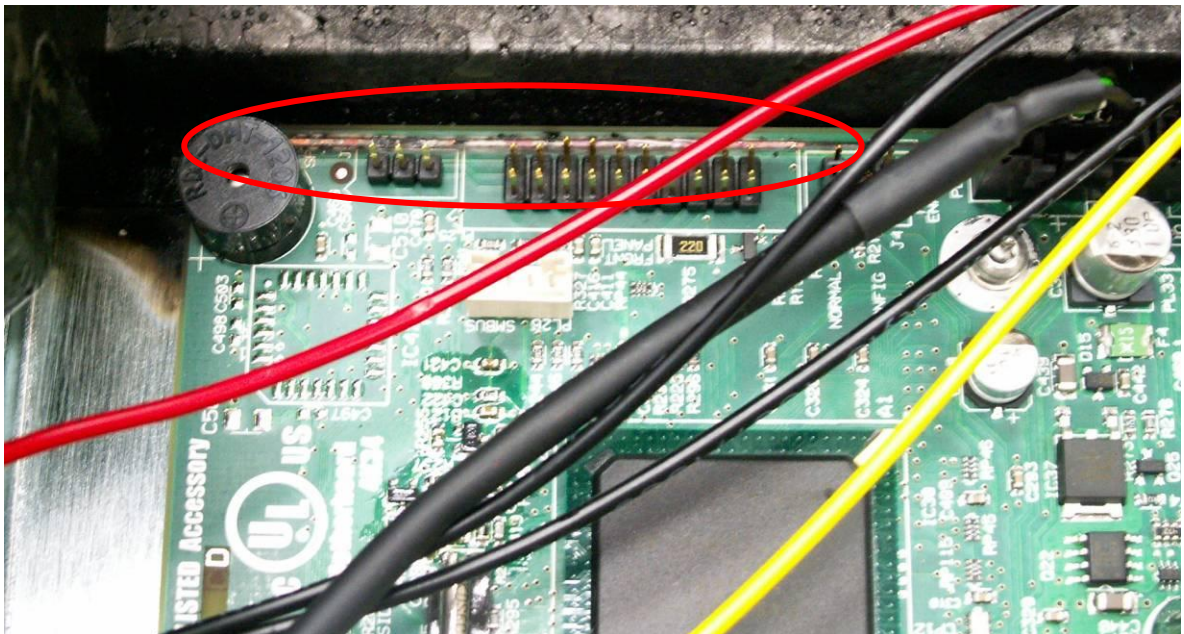
Motherboard considered being bad – please exchange:

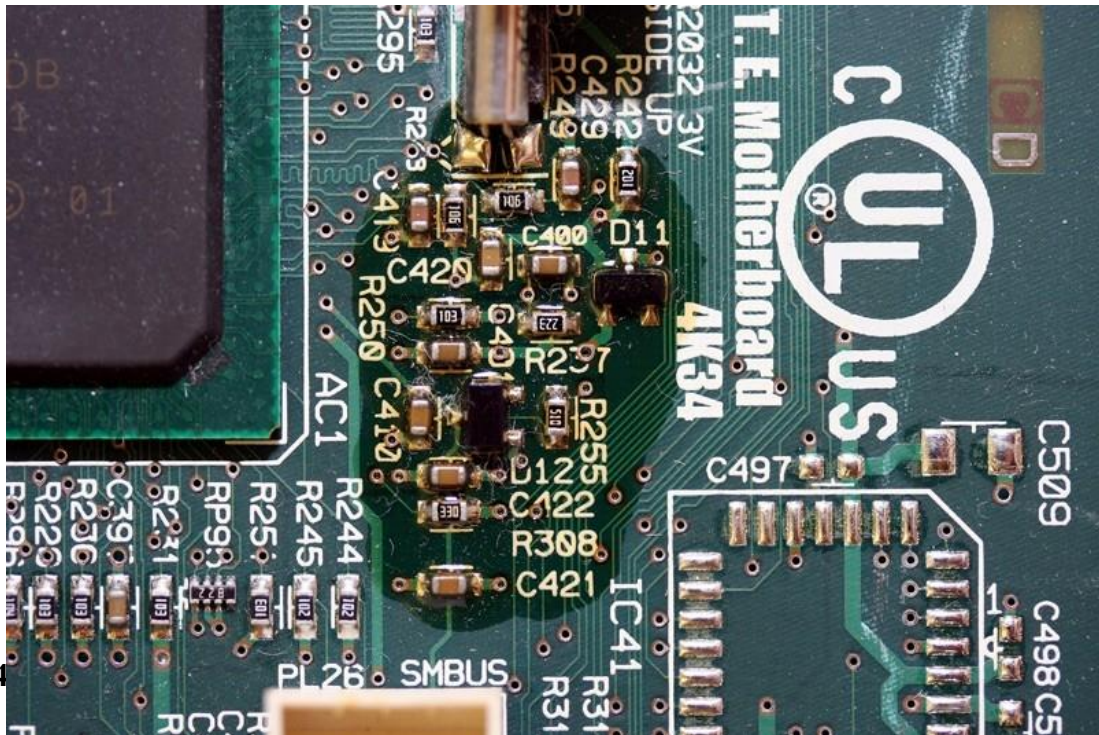
The following discoloring is intentional – no exchange required:

This effect is caused by an intentional sealing of a high impedance area to avoid issues in environments with a high degree of humidity. No exchange of the motherboard is required here.

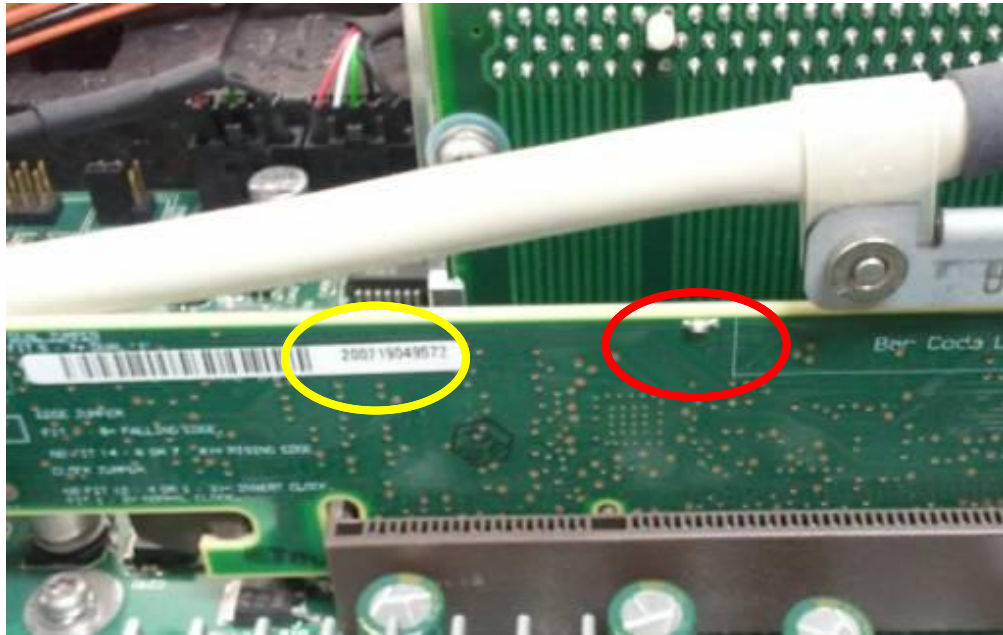
- Sample #1 (Revision NM2501):

The board has a fuse on top (red circle) and a serial number (yellow circle) starting with 200... In the case above it is 200719049572)

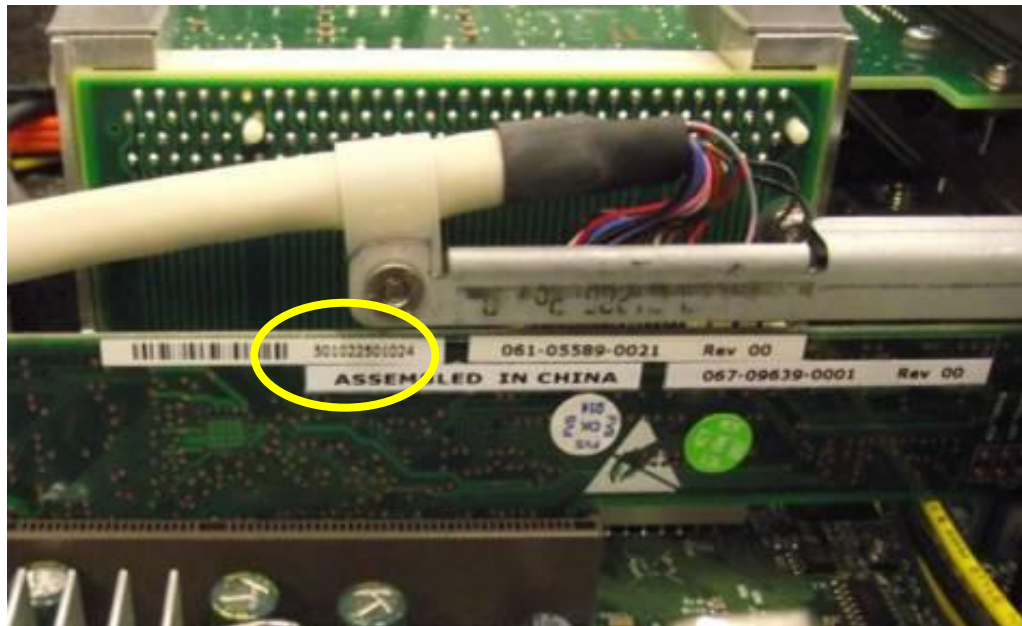
- Sample #2 (Revision NM2502):

The board has a serial number (yellow circle) **NOT** starting with 200... In the case above it is: 501022501024.
