## S E R V I C E N O T E

**83215A RF Interface****Serial Numbers:** 0000A00000 / JP2KA00260**Modification corrects halting ANT IN output due to momentary power failure****To Be Performed By:** Agilent-Qualified Personnel**Parts Required:**

DATE: October 1995

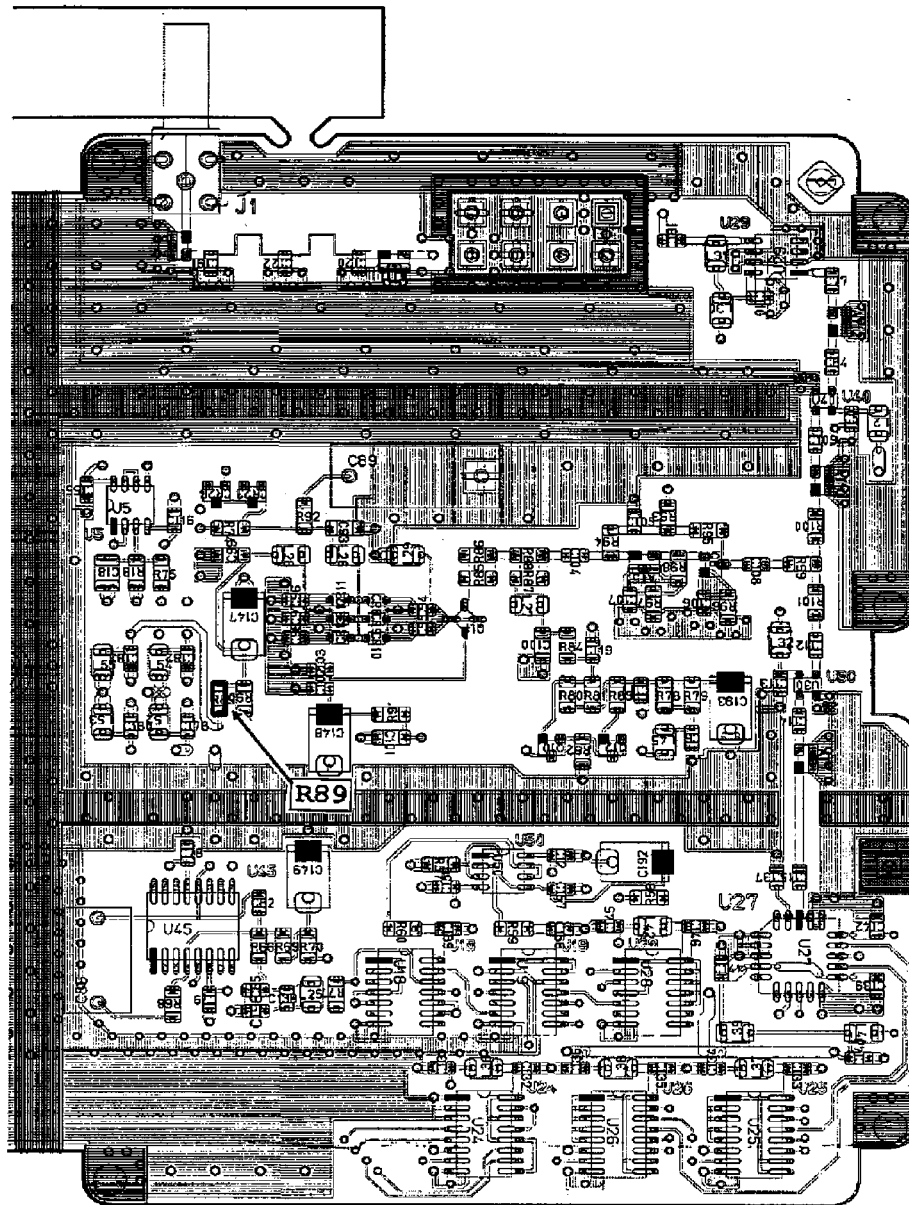
Figure 1.

After 30 minutes warming up, ANT IN output is stopped when a momentary power suspension is occurred. The trouble is due to error on designing VCO circuit.

There are two PC board versions for A4 board. Replace A4R89 with the correct one by referring to either figure 1 or figure 2 according to your board revision.
