## S E R V I C E N O T E

**83215B PHS RF Interface****Serial Numbers:** 0000A00000 / JP2KC00166**Modification corrects error E-53 due to bad temperature drift****To Be Performed By:** Agilent-Qualified Personnel**Parts Required:**

DATE: October 1996

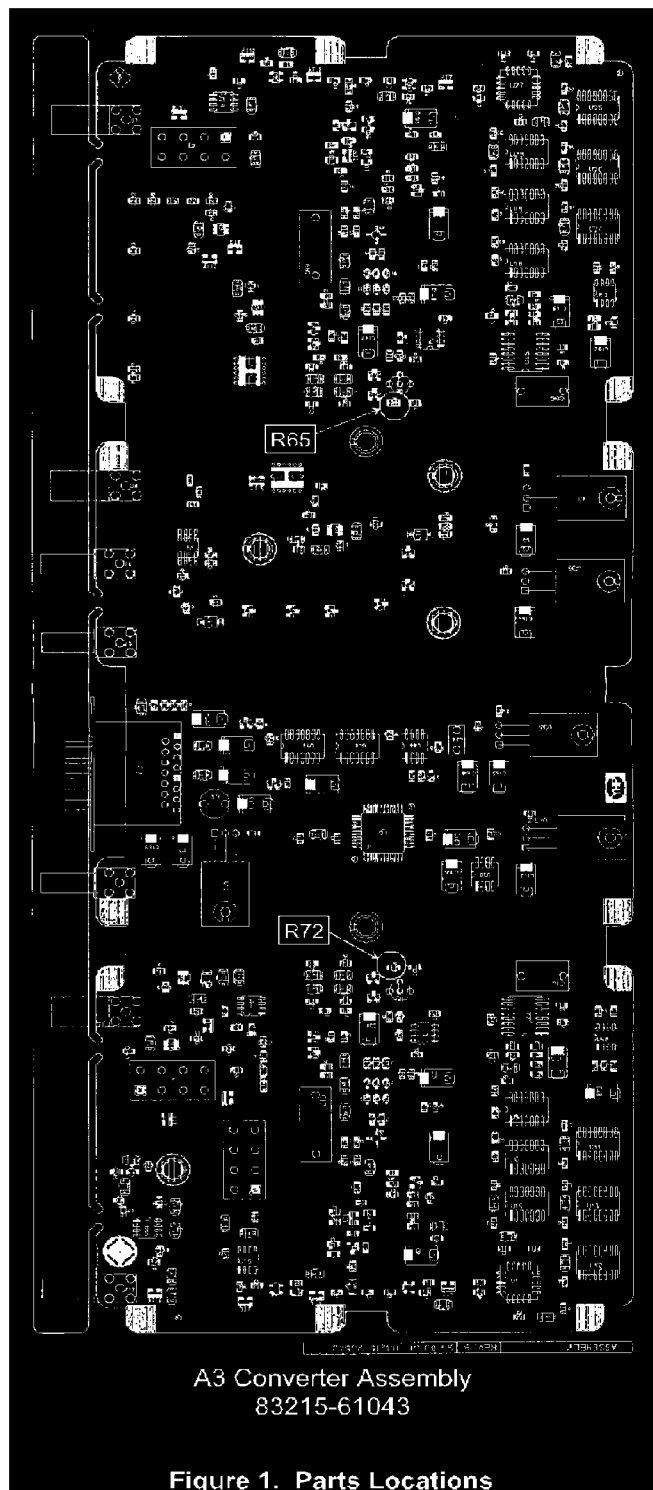
Due to bad VCO temperature drift, E-53 occurs when running 11807C/F.

1. Replace two surface-mounted parts on A3 converter assembly.
  - a. Open cabinet.
  - b. Remove A3 Converter assy (83215-61043).
  - c. Open shield case of the A3 assy.
  - d. Replace R65 and R72 with 0699-3035.  
Parts locations are shown in figure 1.
  - e. Reassemble A3 board and cabinet.
2. Perform required adjustment.
  - a. Run STE/9000.
  - b. Select "83215A\_B" in MODEL SELECTION menu.
  - c. Select "83215B\_ADJ" in SPECIFIC MODEL? menu.
  - d. Perform "[ADJ] DUPLEX OUT TO TXRX INS LOSS B" in TEST LIST menu.
