## S E R V I C E N O T E

SUPERSEDES: 83220A-02A

**83220A/E DCS1800/PCS1900 Test Set****Capacitors being operated out of specification on A4 board****Serial Numbers:**

DATE: June 2001

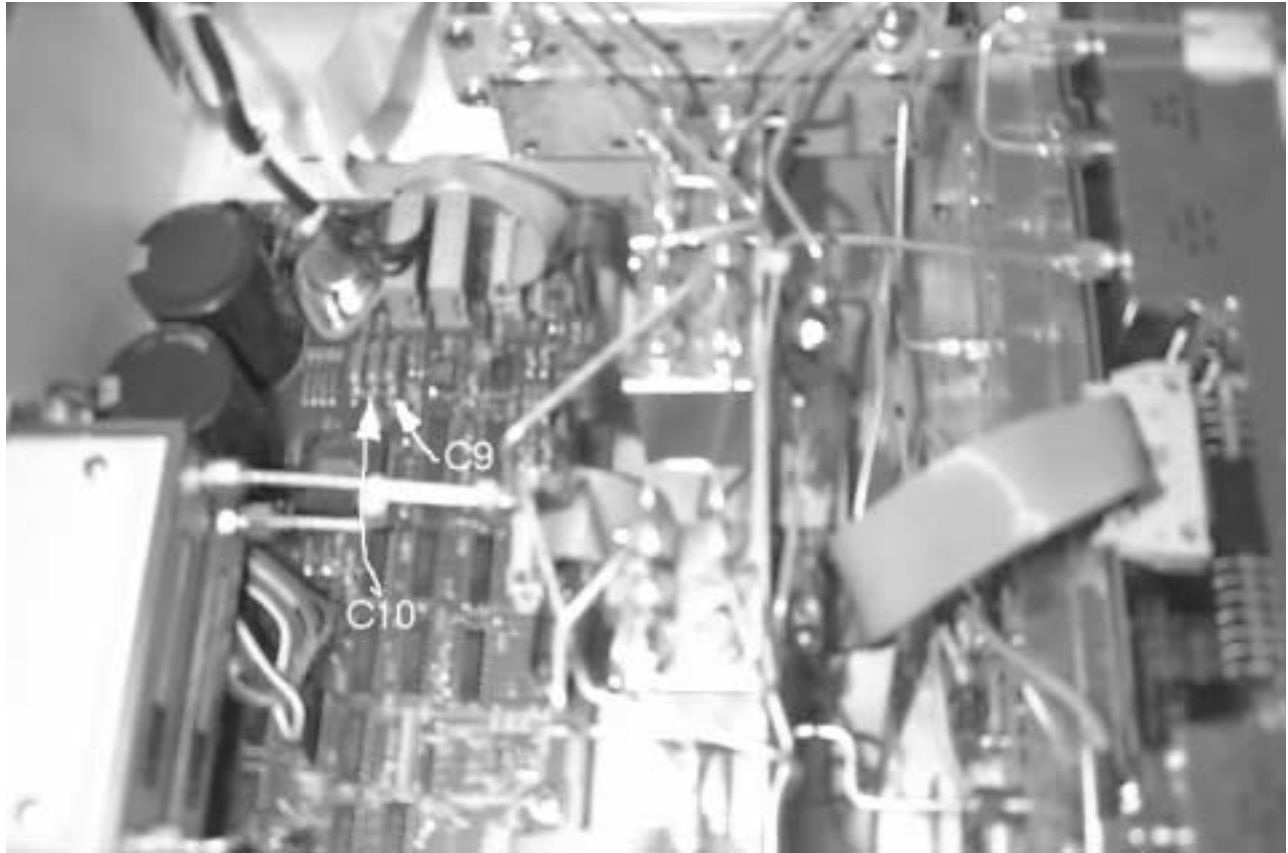
**Figure 5. Capacitors**

It has been identified that two capacitors on the 83220-60004 A4 are being operated out of specification. This may result in either of the capacitors going short circuit and the unit will appear dead.

All 83220's with serial numbers of later than stated above will be fitted with the correct capacitors, as will any units that have been returned to the division since September 1998. The defective type of capacitors can be identified by their yellow colour while the correct type are silver in colour. However all capacitors should be checked for the correct rating and if in any doubt replaced. The correct rating should be 20V.

- 6) Remove the five screws holding the A4 in position.
  - 7) Slide the A4 forward then carefully lift out.
  - 8) Replace capacitors C9 and C10 then refitting is a reversal of the procedure.
- Ensure that all semi-rigids are tightened to 6lb-in.
