**8481A-01**

# S E R V I C E                      N O T E

8481A - Power Sensor, 10 MHz to 18 GHz, -30 to +20 dBm

## Prevention of Bulkhead Lead Wire Breakage

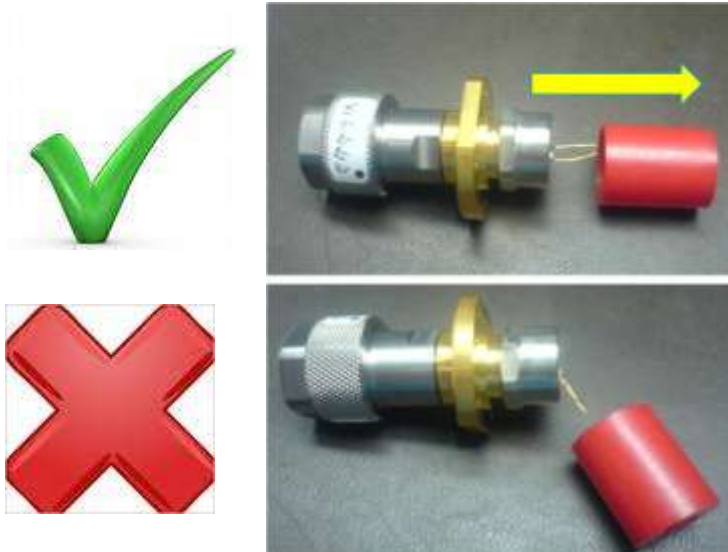
Bulkhead lead wire breakage is due to inappropriate straightening method.

1. Remove the bulkhead cap by a straight pull to the right as shown in the following figure. This is to prevent the bending of the wire.
