**8481A-09**

**S E R V I C E N O T E**

8481A - Power Sensor, 10 MHz to 18 GHz, -30 to +20 dBm

**Prevention of Bulkhead Lead Wire Breakage**

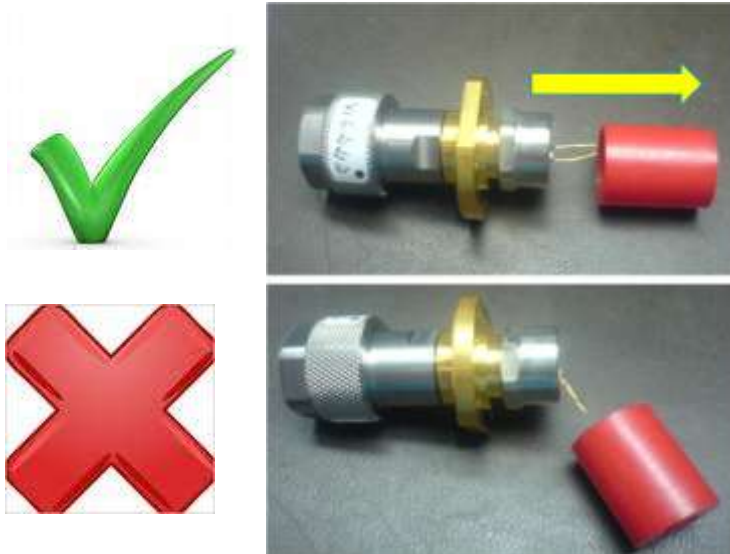
Bulkhead lead wire breakage is due to inappropriate straightening method.

1. Remove the bulkhead cap by a straight pull to the right as shown in the following figure. This is to prevent the bending of the wire.
