8560EC-10

S E R V I C E N O T E

8560EC Series Portable Spectrum Analyzers

Possible interference between Line Switch and LCD Bracket

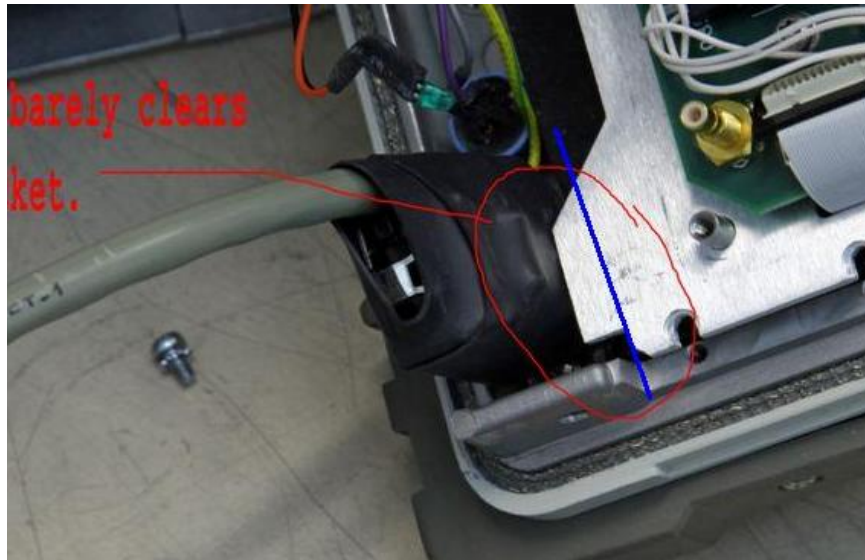
At some point back in 2001 the LCD bracket changed to give more clearance for the front panel line switch. Since that time the size of the line switch has apparently grown. This can be a problem for older instruments, which have the old LCD bracket, when the line switch is replaced with one on the newer switch assemblies (5064-3966), as shown in the image below:

In the past some have attempted to increase the clearance by rotating the line switch 180 degrees, which may only result in a minor amount of additional clearance, and is not recommended.

If there is a problem with the clearance between the front panel line switch and the LCD bracket, as shown in the above image, replace the LCD Bracket with the newer version, which is part number 5000-8314.

[The new 5000-8314 bracket has material trimmed off of it at the point shown by the blues line in the drawing above.]
