# S E R V I C E N O T E

HP 8567A Spectrum Analyzer HP 8568A Spectrum Analyzer HP 8568B Spectrum Analyzer

## **Frequency Spur Correction**

DATE: 21 December 1989

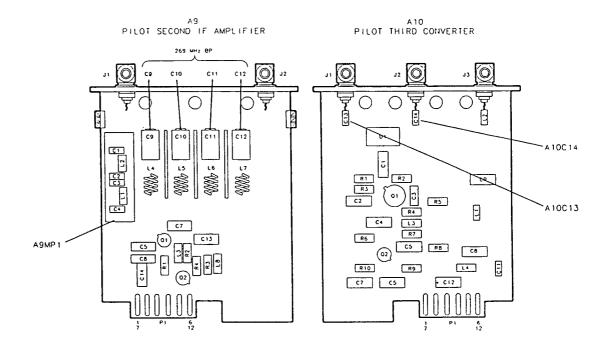
Figure 1. Component Locations

Signals from the A23 RF Converter Assembly feed through the A9 Pilot Second IF Amplifier Assembly and mix with the A10 Pilot Third Converter Assembly. This prevents the spectrum analyzer's meeting specifications for spurious responses (75 dB below -40 dBm total signal power at the input mixer).

The shield is installed over the A9 lowpass filter. First remove the upright shield between this filter and A9C9 and A9L4, if present.

- 1. Separate the two instrument sections and set the IF-Display section aside.
- 2. Remove the two rear feet and the bottom cover from the RF section.
- 3. Using a #1 pozidrive screwdriver, remove the 4-40 screws from around the A9 Pilot Second IF Amplifier and the A10 Pilot Third Converter Assemblies. Remove these assemblies from the instrument and place them on a static-free work surface.
- 4. Solder A9MP1 (HP part number 7100-1304) to the ground plane as shown in Figure 1.

- 5. Install the two 10 pF capacitors on the A10 assembly. See Figure 2.
  - a. Solder one lead of A10C13 to A10J1 and the other lead to the ground plane.
  - b. Solder one lead of A10C14 to A10J2 and the other lead to the ground plane.
- 6. Install the A9 and A10 assemblies into the RF section.
