# S E R V I C E N O T E

# 85942A Video Signal Monitor

## **Line Module Wire-Routing Modification**

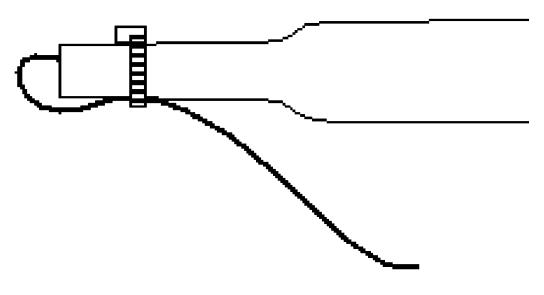
Figure 1

These instruments have two wires that come out of the power supply line module and go to the power supply assembly. With the current routing, these wires pass close to capacitor C25 on the power supply assembly. The wires are properly insulated, however, a break in the insulation could conceivably result in a safety problem. This a a MINIMAL risk, but is actioned as a result of a CSA approval requirement.

The wires can be tied back, so that adequate separation between the wires and C25 is maintained. Add one tie-wrap (1400-0249) to the BLUE wire, and one tie-wrap to the BROWN wire. Attach to each wire, as shown in Figure 1.
