86100C-12A

S E R V I C E N O T E

86100C Digital Communications Analyzer Mainframe

Motherboard board mounting modification improves product reliability related to boot up issues.

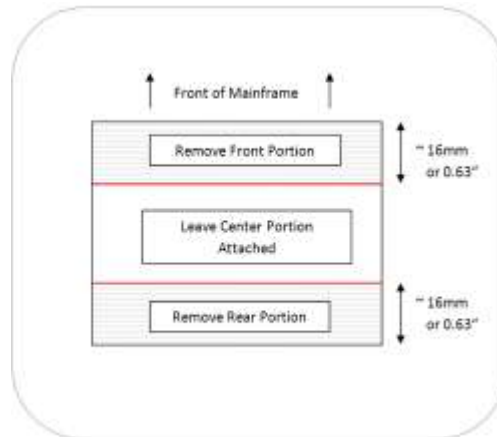
Foam mounted underneath the microprocessor board to prevent vibration during shipment may flex the board more than desired on some units, resulting in intermittent power-on failures. Modifying the foam as described reduces the flex and improves reliability.

Modify the foam as described below. The modification will remove roughly half of the foam, equally from the front and rear, leaving a strip in the center.

This modification should be completed on all affected 86100C mainframes, even if the unit is not currently showing boot failures.

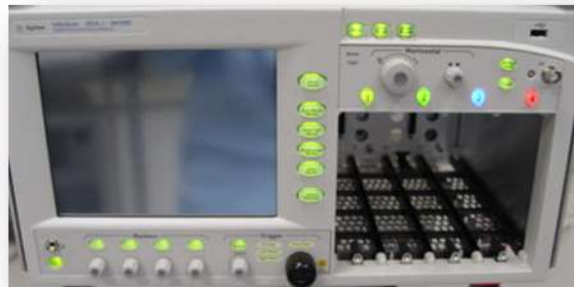
The most common symptom is a boot up error as shown here. The mainframe will come to the point where all LEDs are lighted but will not progress through the boot sequence.

This can be either a hard failure or very intermittent.

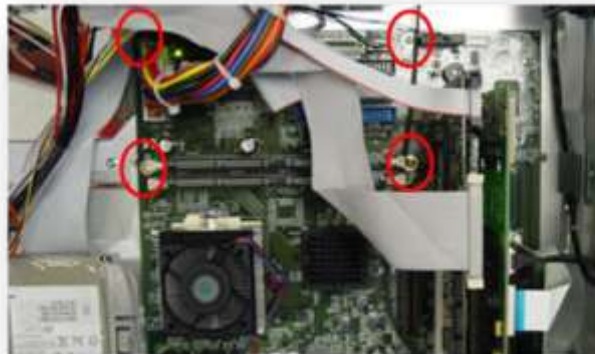
To verify the problem is related to the board flexing issue:

1. Power the instrument off and remove the cover.
2. Loosen the four screws indicated here.
3. Re-boot the instrument.
4. If it boots normally, then board flex caused by the foam is a likely cause.
