## S E R V I C E N O T E

**8751A Network Analyzer**

**Modification to fix unexptected spurious problem.****To Be Performed By:** Agilent-Qualified Personnel**Parts Required:**

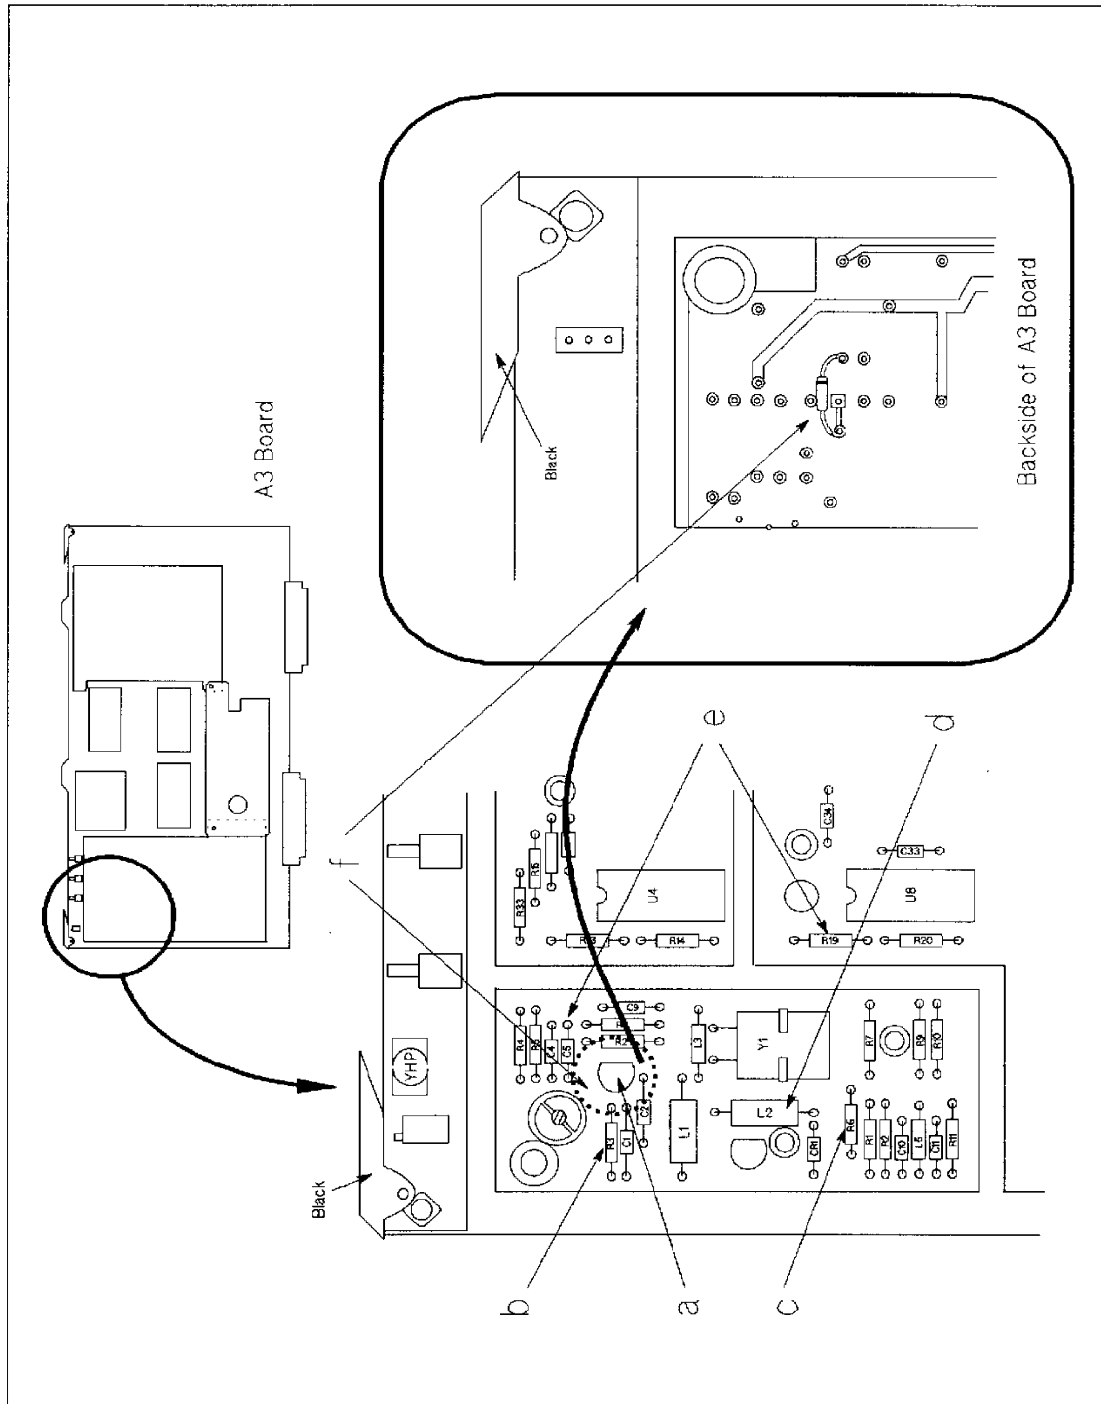
Figure 1. A3 Board Modification

The 8751A may show the unexpected spurious response due to the parasitic oscillation of the source signal.

This is caused by the breakdown of A3Q2 transistor. This symptom can be confirmed using the following procedures:

1. Turn the 8751A off. Remove the top cover and the shield plate.
2. Remove the A3 board.
3. Modify the A3 board with referring Figure 1:
  - a. Replace the A3Q2 transistor (P/N 1854-1073) with the new one.
  - b. Replace the R3 resistor. 464 ohm --> 1 kohm (P/N 0757-0280)
  - c. Replace the R6 resistor. 464 ohm --> 316 ohm (P/N 0698-3444)
  - d. Replace the L2 inductor. 680 nH --> 470 nH (P/N 9100-3548)
  - e. Replace the location of C5 (0.01 uF, P/N 0160-4832) and R19 (215 ohm, P/N 0698-3441).
  - f. Add the diode (P/N 1901-0050) with referring Figure 1.
4. Perform the following adjustments:  
100 MHz VCXO Frequency  
Fractional N Osc Spurious  
1st IF Offset Osc Frequency  
LF power linearity
5. Reinstall the A3 board.
