## 8757D-01

# S E R V I C E N O T E

## 8757D Scalar Network Analyzer

Serial Numbers: AA00000000 - MY46060400 (see "Additional Information" below)

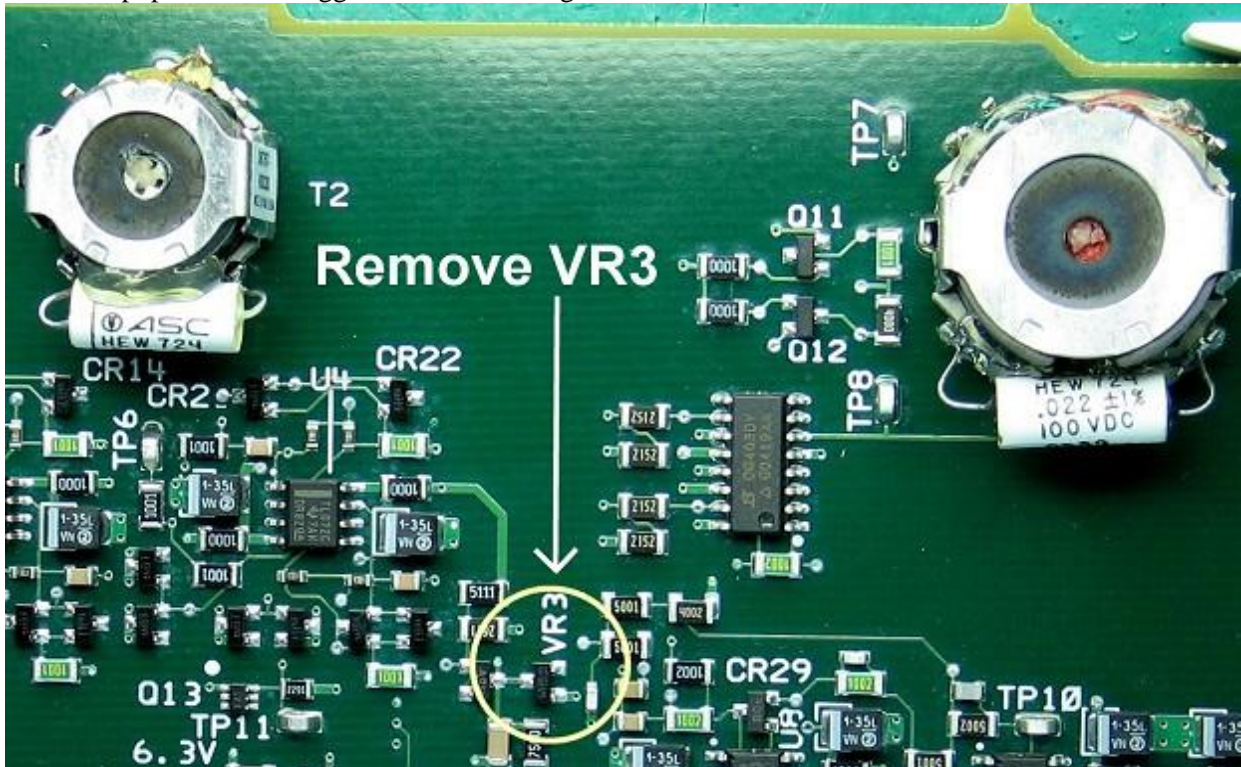
When the 8757D logger board was changed to use surface mount parts (sometime around 2003), a 6.2 V reference Zener diode (VR3) was used that did not meet the required temperature drift specification. This diode may cause the 8757D to fail its dynamic accuracy test as measured with the 11613A/B. Typically it may fail if the temperature drifts by more than 2 degrees from that used on its original calibration. While this may cause the dynamic accuracy test to fail, the customer's end result measurement will most likely not be affected significantly. This is because the added error due to the temperature drift is typically under 0.1 dB while the detector specification is 0.4 dB or more. In addition, other scalar uncertainties, such as mismatch errors, will push the total measurement uncertainty to about +/- 1-2 dB. As a result, the 0.1 dB increase in error is probably negligible

**Figure 1.** Locate and remove VR3

If an unmodified logger board is found, the Zener diode VR3 should be removed (see figure 1.) The new Zener diode should be connected to the same location via two wires. Once properly soldered, it should be glued in place using quick-setting (5 minute) epoxy. Make sure that polarity is observed. See figure 2 for placement. Allow time to cure. Once the instrument has been reassembled and warmed up, perform the logger calibration using the 11613A/B calibrator.
