**8903B-08**

# S E R V I C E N O T E

## 8903B Audio Analyzer

### **Motherboard Bumper Feet Deteriorate/Breakdown Over Time**

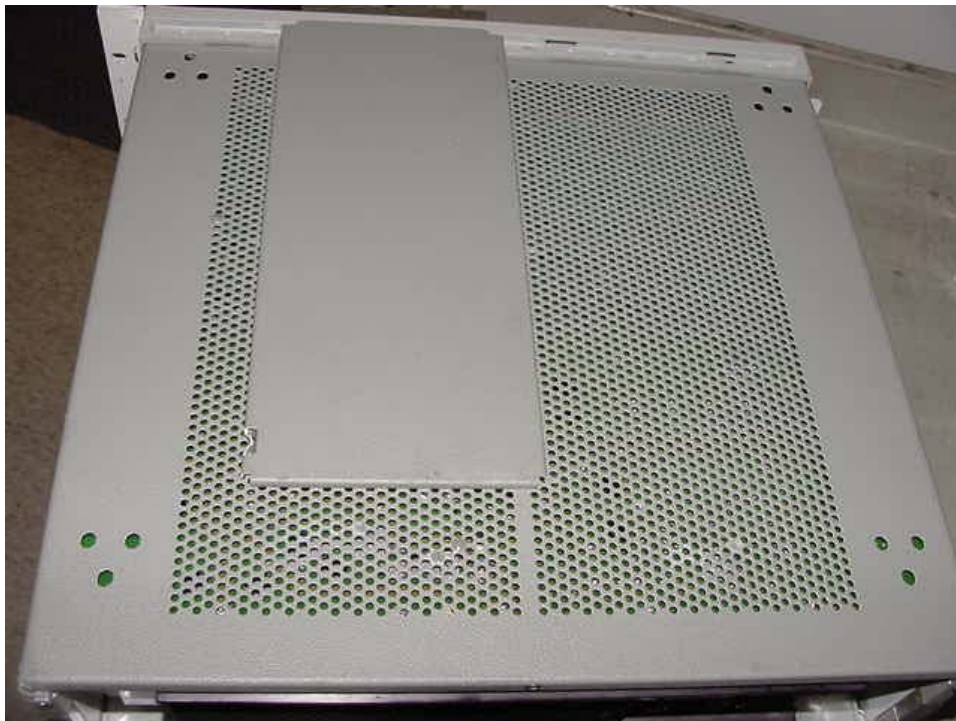
**Figure 1 – External Bottom Cover**

Inspect the motherboard bumper feet through the ventilation holes in the external bottom cover (Figure 1). Defective bumper feet can be identified by a melted appearance (Figure 2) or a 'goosey' residue (Figure 3) on surfaces or instruments underneath the Agilent 8903B.

Disconnect AC power from the instrument, remove the external bottom cover, identify and remove defective bumper feet, clean the surface and replace them with part number 0403-0285. Re-calibration is not required.

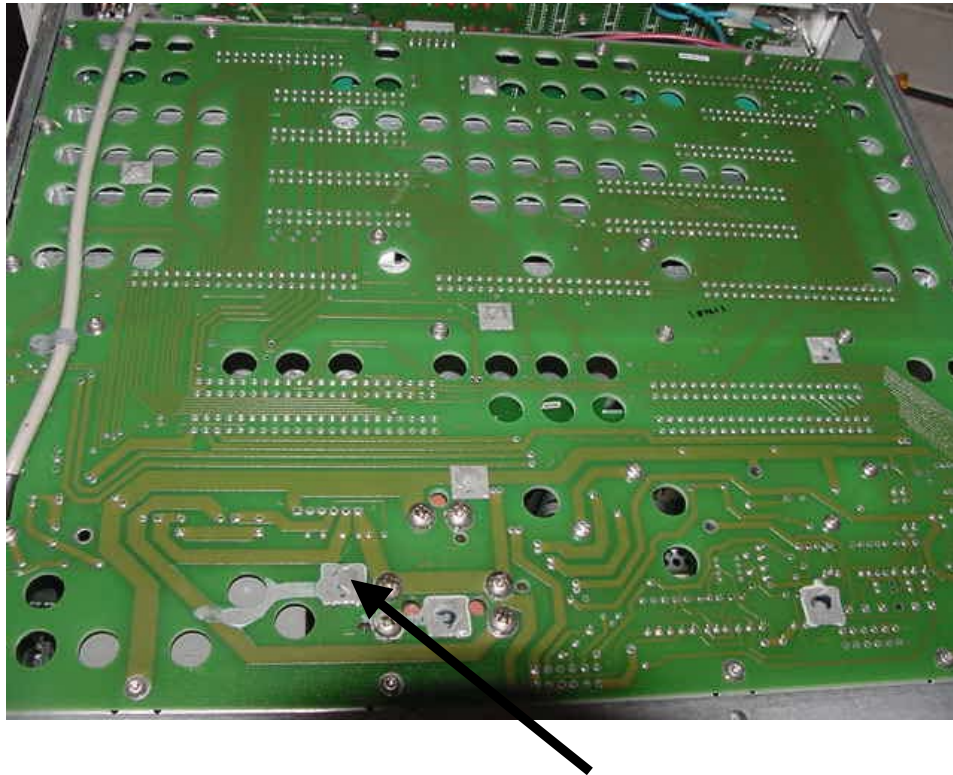
The motherboard bumper feet prevent contact between the bottom external cover and circuit traces on the motherboard. For instruments with serial prefixes noted above, these bumper feet may deteriorate or breakdown over a period of time.

**Figure 2 – Defective Bumper Feet**

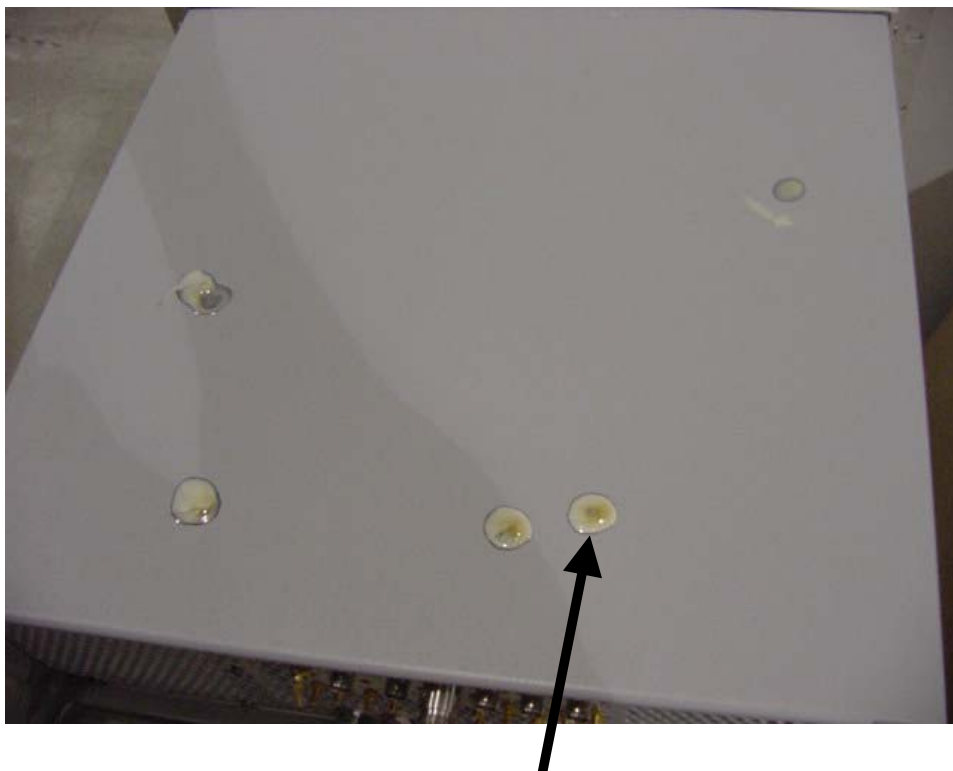
**Figure 3 – 'Goeey' Residue**
