**S E R V I C E N O T E**

**B1500A Semiconductor Device Analyzer Mainframe**

**Interlock operation speed is improved when using ASU**

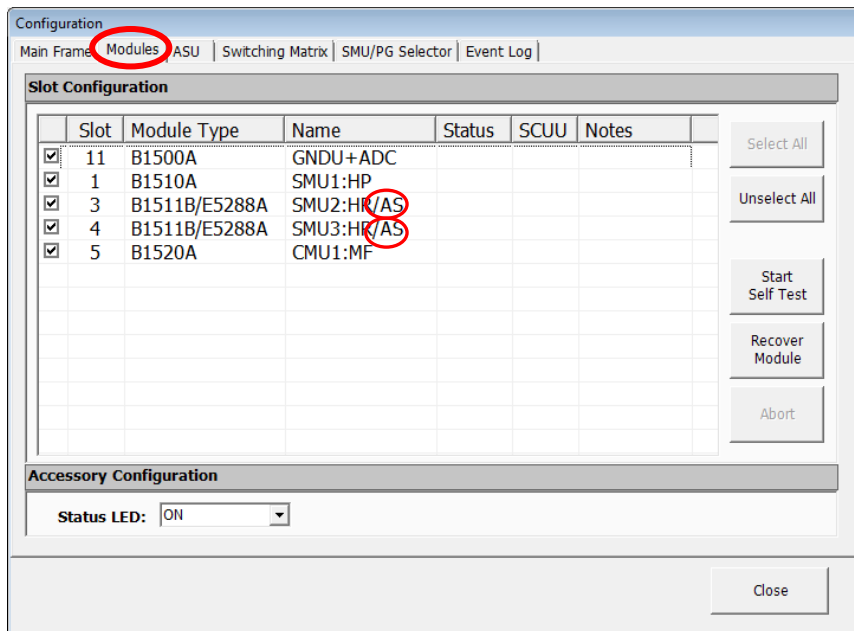
- Start EasyEXPERT and go to "Configuration" window.
- Click "Modules" tab.
- Check if ASU is displayed in the module list as shown below. (It should be displayed as "AS")

If your instrument does not have the ASU, then this Service Note does not apply.

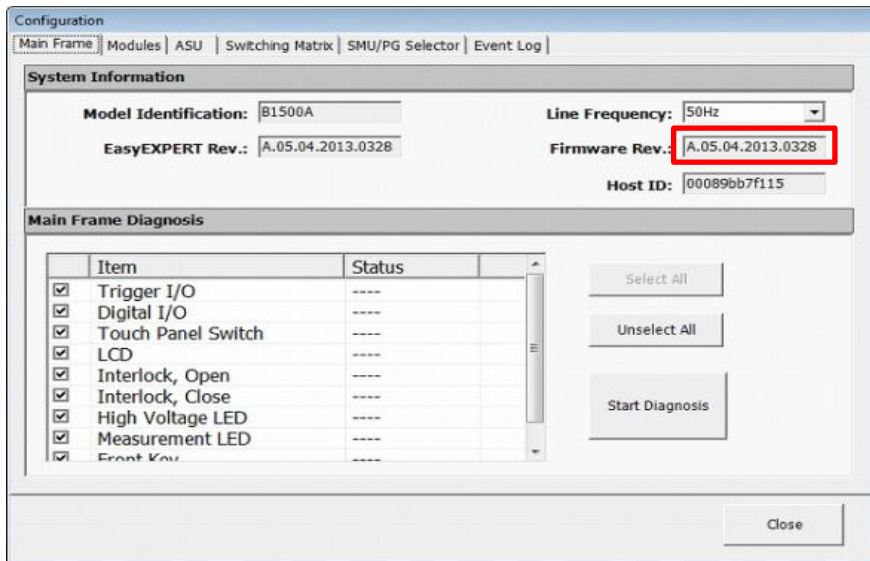
- (b) Check the firmware revision of the instrument as follows.
- Start EasyEXPERT and go to “Configuration” window.
  - Check the firmware revision displayed in the “Firmware Rev.:
- (indicated by ‘red’ square in the screenshot below.)

If the revision displayed is A.05.05 or A.05.51 or later, then this Service Note does not apply.  
If the revision displayed is A.05.04 or earlier, or A.05.50, proceed to the next step.

Step 2: Updating the firmware to A.05.05 or A.05.51 (or later) by installing EasyEXPERT Software.  
(Note: This can be done, without contacting Keysight.)
