# DSA90404A-06A

## S E R V I C E N O T E

### DSA90404A Infiniium High Performance Oscilloscope: 4GHz

Serial Numbers: MY00000000 up to MY49470100 and SG00000000 up to SG49470100

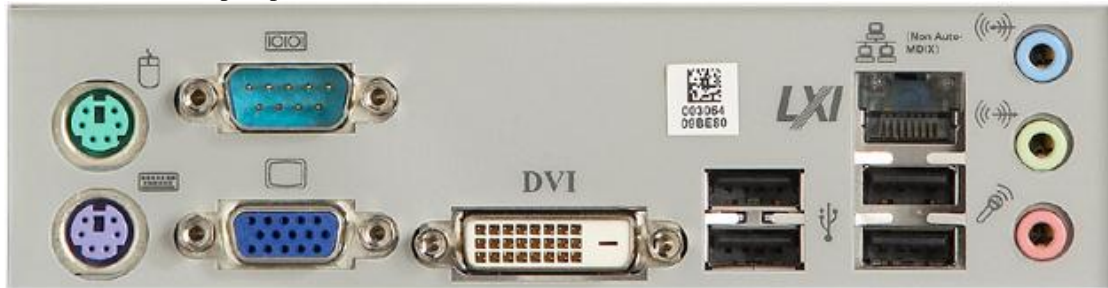
The easiest way to recognize the M880 motherboard from the M890 motherboard is the White DVI connector on the motherboard port panel. If the motherboard has this white DVI connector it is a M890 motherboard.

M890 Motherboard port panel.

The repair is to replace the M880 motherboard and SATA cables, using the M880 Motherboard Replacement Kit, part number 54913-68719.
