## DSAX96204Q-01

# S E R V I C E N O T E

## DSAX96204Q Infiniium High-Performance Oscilloscope: 63 GHz

Serial Numbers: MY00000000 - MY53300100, SG00000000 - SG53300100

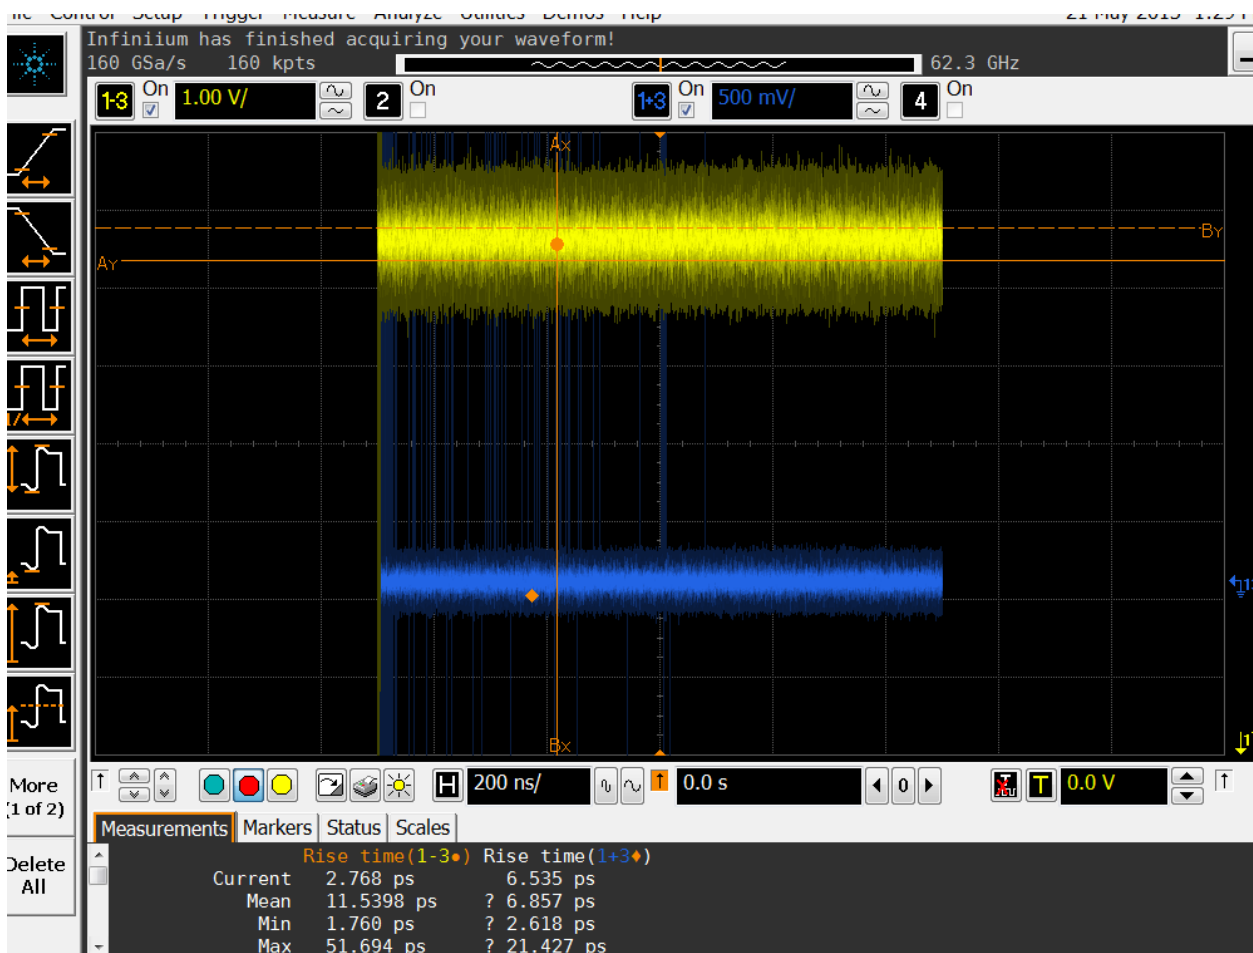
Using the Real Channels with differential mode on and or Precision Probe on, causes the Main FPGA to dip and data fryers are observed due to voltage variations.

Starting in July 2013 week 33 and ECO was implemented changing the power supplied to the Main FPGA. This fixed the Real channels having Data Flyers due to voltage variations. Scopes shipped previous to this ECO need to be updated to the reworded Backplane assembly.

Example of the data flyers:

Replace Backplane assembly following the service manual procedure. Factory Calibration is required after the backplane replacement.
