DSO6014L-01-S

## DSO6014L Oscilloscope, LXI, 4-channel, 100 MHz

Safety Service Note

## POSSIBLE "SHOCK" HAZARD

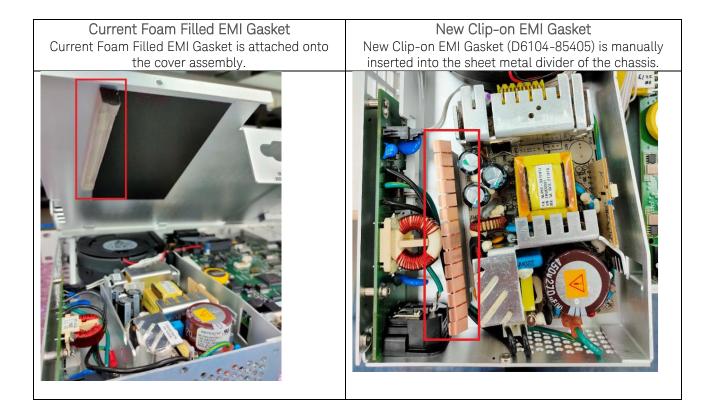
The current Foam Filled EMI Gasket (implemented in Nov 2019) in the 6000L series scopes was placed incorrectly and may not meet the safety creepage and clearance requirements and could a cause safety risk to the user, therefore the cover assembly and EMI Gasket need to be replaced. This is ONLY APPLICABLE FOR the units with the designated serial numbers which will be RECALLED back to SSU for repair.

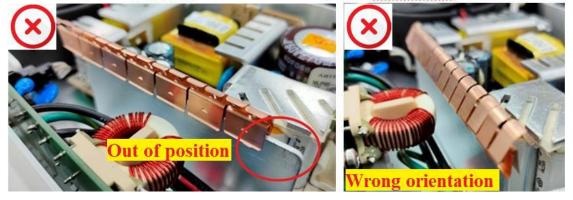
Example of WRONG placement of EMI gasket Fingerstock as below:
