DSO6104L-01-S

### Safety Service Note

### DSO6104L Oscilloscope, LXI, 4-channel, 1 GHz

POSSIBLE "SHOCK" HAZARD

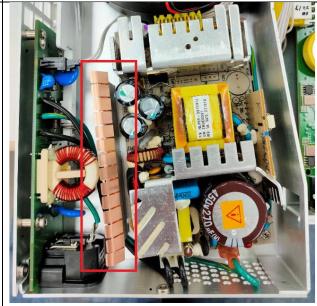
# New Clip-on EMI Gasket New Clip-on EMI Gasket (D6104-85405) is manually inserted into the sheet metal divider of the chassis.
