DS09104A-08

# Information Only Service Note

# DSO9104A - Infiniium DSO, 1GHz, 10/20 GSa/s, 4Ch

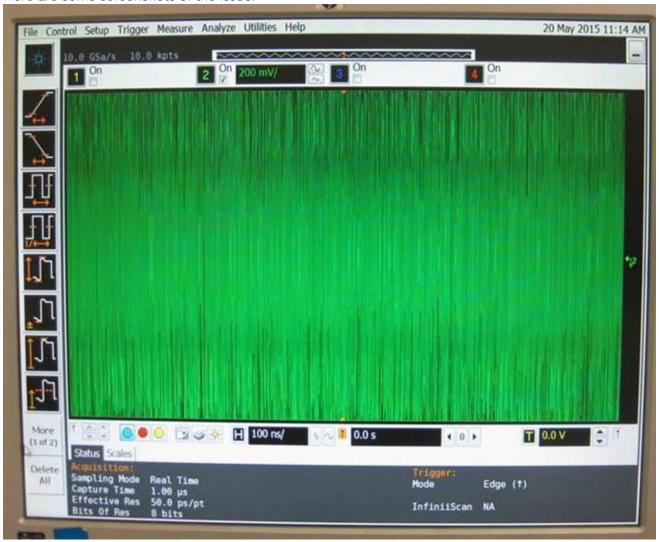
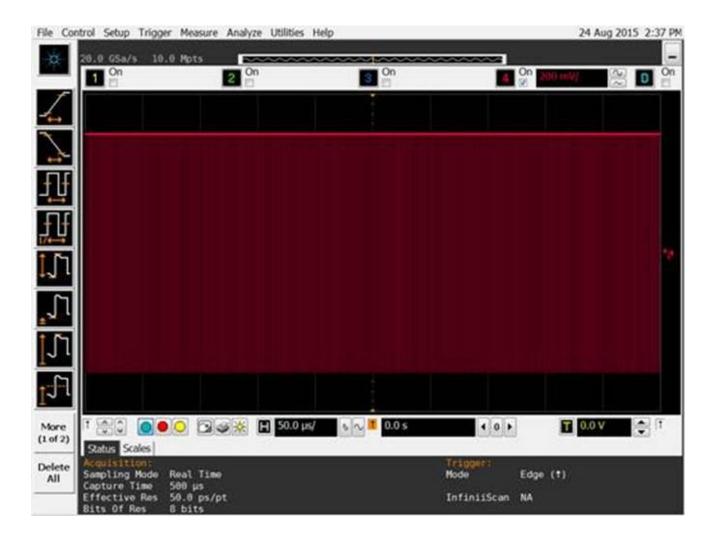
Upon completion of service or user calibration if the customer is not ok with upgrading the revision of software of the scope to >5.50.0033, there is a chance that the unit may end up with excessive noise on the screen at certain vertical settings.

- 1. Noise appears all over the screen after performing service/user calibration.
- 2. The noise on full screen could happen on any channel in 50 Ohm impedance on certain vertical settings. Some instances occurs at 200mV/div and not on other settings, whereas some occur at 10mV/div and not on other settings.

Here are some screenshots of the issue:

Install revision of software 5.50.0033 or higher.
