DSO9254A-03

S E R V I C E N O T E

DSO9254A - 2.5GHz Digital Signal Oscilloscope

Repair for Windows "Power surge on hub" message

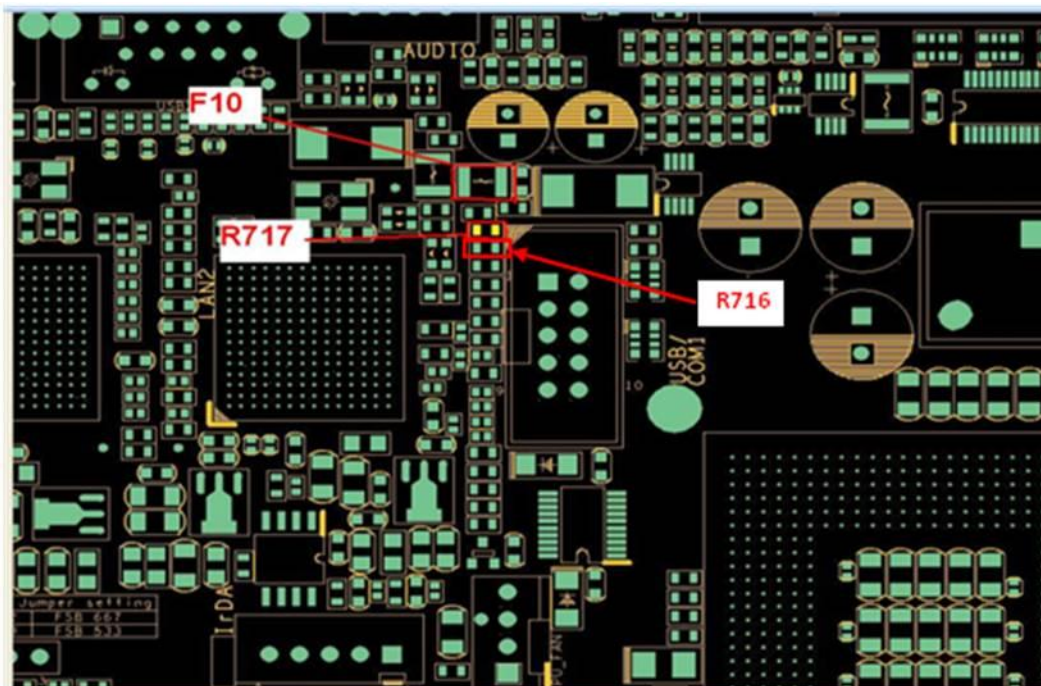
F10 – 0837-3854 Thermistor

R717 – 0699-7654 10K Resistor

R716 – 0699-5789 15K resistor

1. Refer to the service manual to remove the motherboard from the scope.
2. Install the three components from the upgrade kit on the motherboard. Refer to the below drawing and the drawing on the next page for component locations. The 0960-2789 motherboard is RoHS compliant and the below three components are also RoHS compliant. You should use a RoHS soldering station and RoHS solder techniques when possible.
