DS09404A-08

# Information Only Service Note

DSO9404A - Infiniium DSO, 4GHz, 10/20 GSa/s, 4Ch

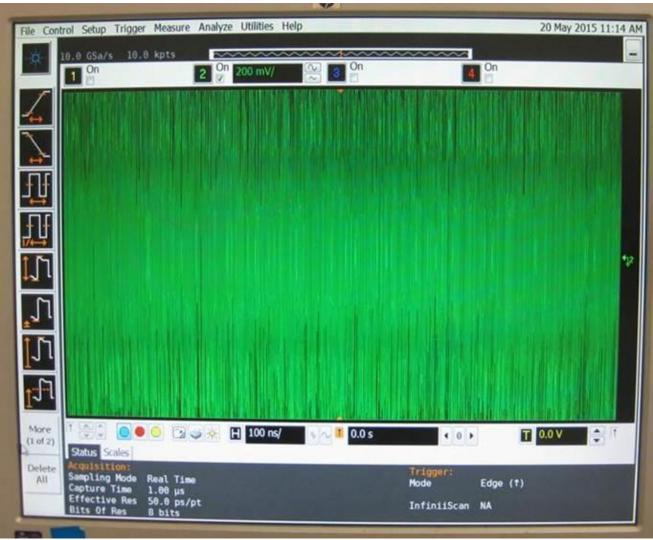
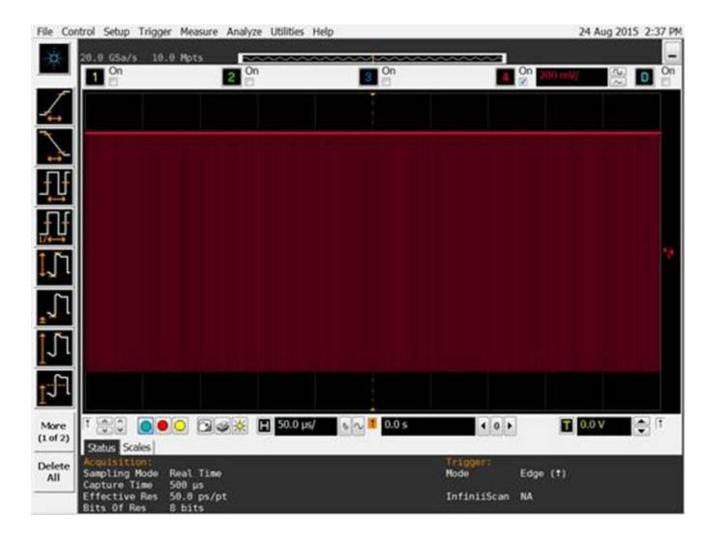
- 1. Noise appears all over the screen after performing service/user calibration.
- 2. The noise on full screen could happen on any channel in 50 Ohm impedance on certain vertical settings. Some instances occurs at 200mV/div and not on other settings, whereas some occur at 10mV/div and not on other settings.

Here are some screenshots of the issue:

Install revision of software 5.50.0033 or higher.
