DSOS204A-02B

# Modification Recommended Service Note

## DSOS204A – DSO Infiniium S Series 2GHz 4 channel

The Problem – Under certain circumstances a PLL2 error may occur on the S-series products.

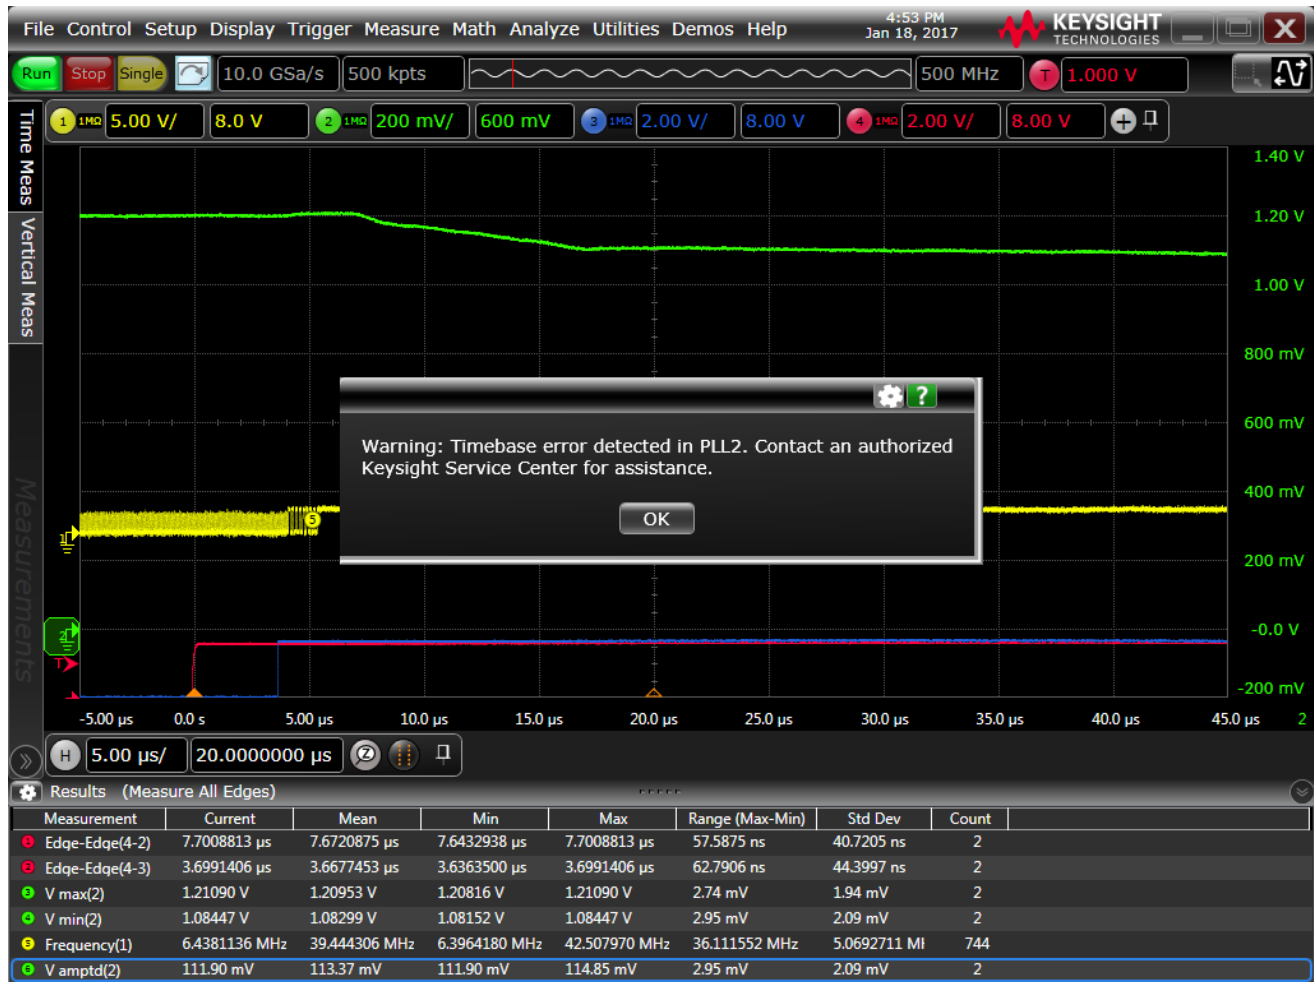
On older acquisition boards a PLL2 error message sometimes occurs. The error message appears on the screen as below:

There are new acquisition boards that fix this issue for the S-series scopes.

1. If the customer needs to have software revision < 6.10, then replace the acquisition board with the 54911-69532 board.
2. If the customer can have software revision > 6.10, then it can be replaced by any of these three boards: 54911-69521, 54911-69531, or 54911-69532.
3. Save the Serial Numbers of the replaced and the new Acquisition Boards in Siebel. Please, follow this procedure:
  - a. For each Service Order in Siebel, there is a tab labeled Activities:
