# DSOX93204A-03

### DSOX93204A 32GHz Digitizing Oscilloscope

Serial Numbers: MY00000000 up to and including MY50270103

**Front panel connector may not offer a good ground connection for probes**

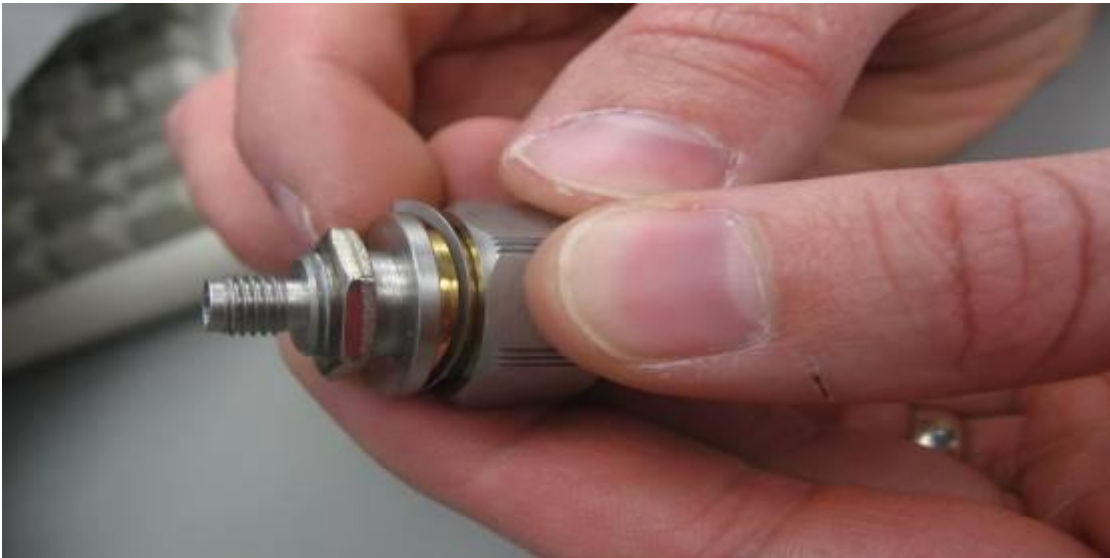
The front panel connector may not provide an adequate ground for N280XA probe amps. You may see more trace noise than you would expect.

You do not need to disassemble the covers from the instrument. If the scope was recently repaired, it is possible the fix was already implemented. You can lightly tap on the outer gray clutch that surrounds the channel input connectors. The clutch will move in a couple of millimeters. If the spring was installed, it should pop back out. Also, if you look carefully, you may see the spring on the input connector. Below is a picture from production showing the spring installed before the front panel connector is installed in the scope. You do not need to remove the front panel connector to install the spring.

Read the entire procedure before starting so you fully understand the process. Some of the pictures are from manufacturing. You do not need to disassemble the scope for this repair.
