DSOX95004Q-01

S E R V I C E N O T E

DSOX95004Q Infiniium High-Performance Oscilloscope: 50 GHz

Serial Numbers: MY00000000 - MY53300100, SG00000000 - SG53300100

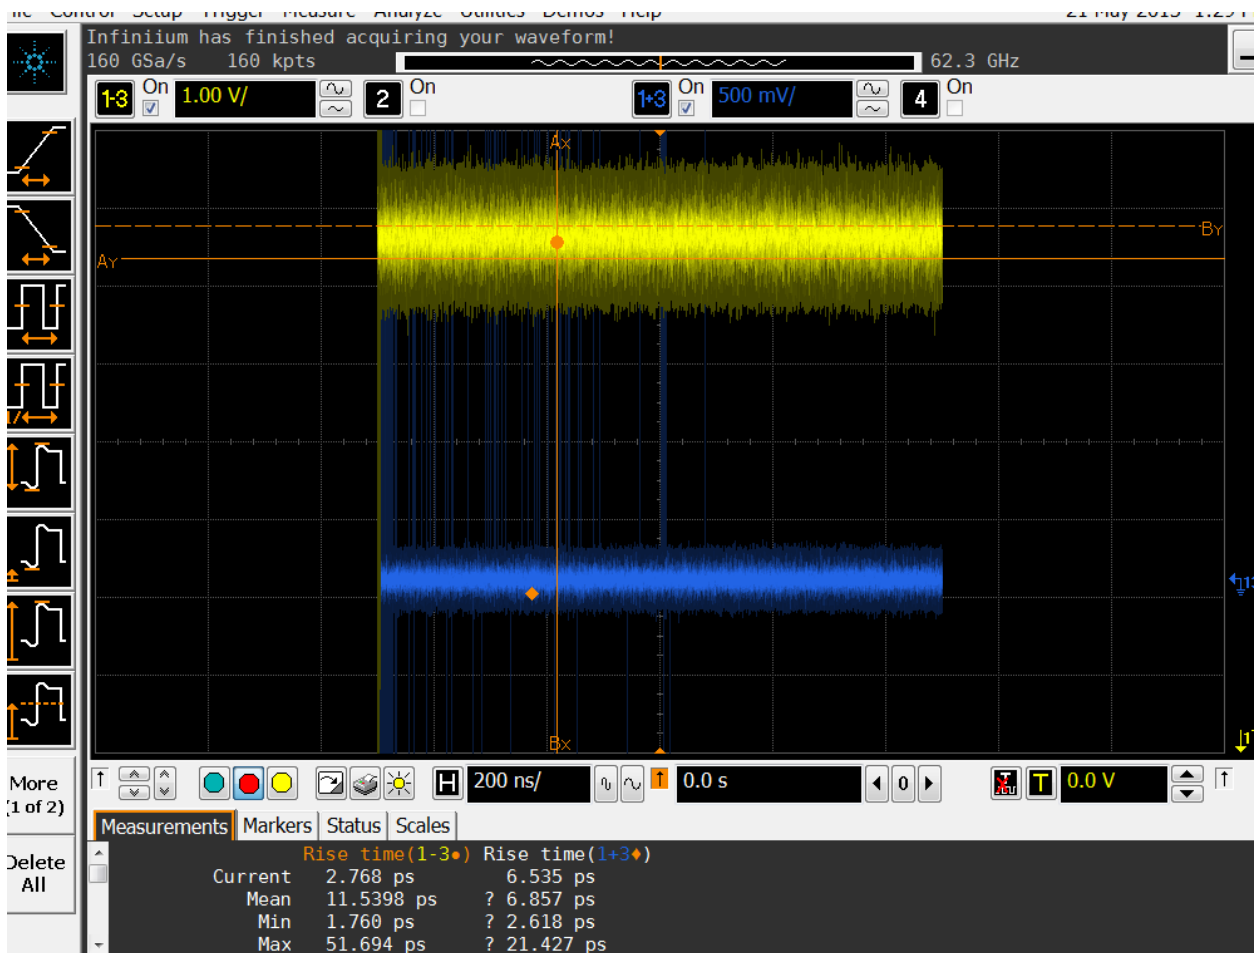
Using the Real Channels with differential mode on and or Precision Probe on, causes the Main FPGA to dip and data fryers are observed due to voltage variations.

Starting in July 2013 week 33 and ECO was implemented changing the power supplied to the Main FPGA. This fixed the Real channels having Data Flyers due to voltage variations. Scopes shipped previous to this ECO need to be updated to the reworded Backplane assembly.

Example of the data flyers:

Replace Backplane assembly following the service manual procedure. Factory Calibration is required after the backplane replacement.
