# S E R V I C E N O T E

# E1446A C-Size VXI Summing Amplifier/DAC

**Serial Numbers:** 3223A00101 / 3223A00192

Modification to prevent output from sticking at the +24 VDC or -24 VDC rail.

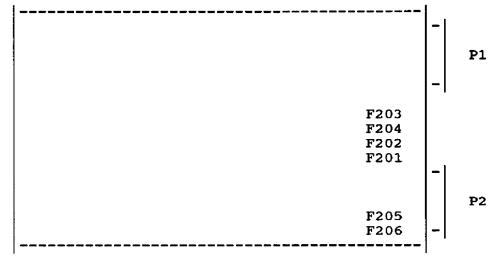
When the E1446A is used in some VXI C-size mainframes (particularly the E1401A), occasionally one of the E1446A fuses in the + and -24 VDC supply lines (F205 and F206) may open when power is applied to the mainframe. The E1446A appears to have some inrush current at power-up that occasionally exceeds the time/current rating of the existing 1 Amp fuses.

The symptom of the open-fuse condition is when the output of the E1446A sticks at either the +24 VDC or the -24 VDC supply rail.

When the symptom described above occurs, replace all six of the E1446A on-board power supply fuses (F201-F206) with fuse p/n 2110-0699 as follows:

- 1. Remove the top shield from the E1446A:
  - a. Loosen (but do not remove) the locking nuts on the five BNC connectors on the front panel.
  - b. Remove the seven T10 torx screws holding the shield to the PC board.
- 2. Orient the PC board with the connectors to the right. Locate the ERC code label in the lower L/H corner. If the ERC code is smaller than 3313, proceed to step 3 below. If the ERC code is 3313 or greater, this E1446A has already received the modification described in this service note. Check the fuse (F201-F206) for continuity and replace any fuse that is open. Reassemble the units and test. If the output is still stuck at + or -24 VDC, the fuse has probably opened again. Replace the whole module with an exchange assembly (p/n E1446-69201).
- 3. Replace all 1 A fuses (F201-F206) with 5 A fuses (p/n 2110-0699).
