E1460A-01 S E R V I C E N O T E

## E1460A 64 Channel Relay Multiplexer

E1460A may fail to open/close relays because of a defective relay driver IC with date code 0325.

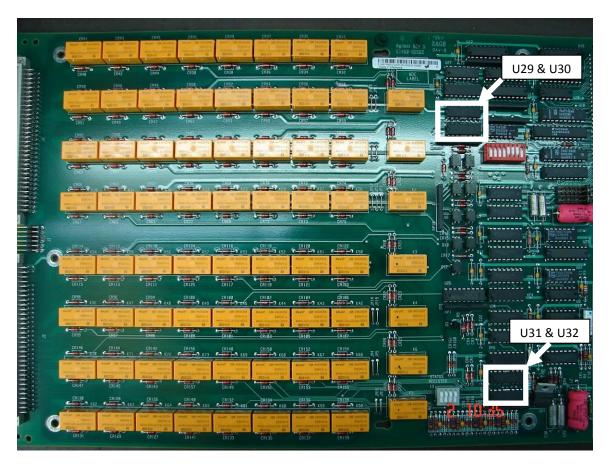
PCA PN: E1460-66702

The relay driver ICs are U29, U30, U31, U32 which are the LTB part 5188-2550 for 1820-4599. The bad date code is 0325. This date code has a higher than normal failure rate. Most failures have occurred in the first three months of usage. See the following pictures for part and date code location

Location Impacted: U29, U30, U31 & U32

A E1460A that fails to close or open it's relays and has the 0325 date code ICs should be replaced with a E1460-66702.
