E3101A-17

S E R V I C E N O T E

4071A Semiconductor Parametric Tester

Cable Stoppers Prevent to Loosen Extended Path Cable

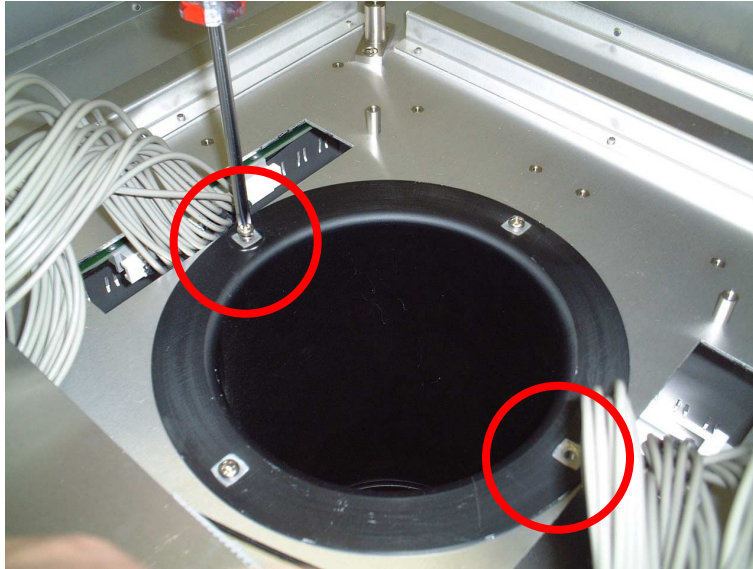
The contact check of PV relay test may fail in some pin boards. Swapping the failed pin board does not move the problem symptom.

1. Remove the cover opposite side of measurement pins.
2. Remove two screws fixing the cylinder near the extended path cables.

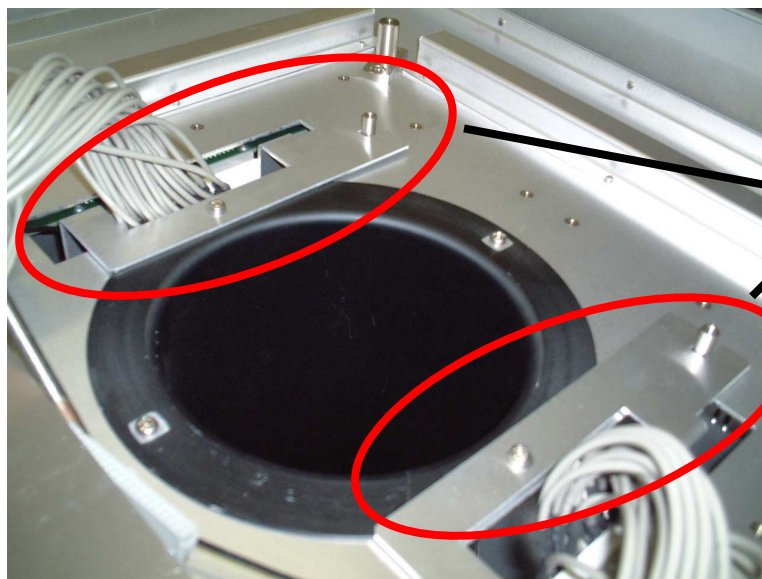
Cable Stopper

The PV relay test fail may be caused by loose extended path cable. Check if the extended path cable is connected tightly. If the extended path cable is loose, attach the cable stoppers to the connection between extended path cables and matrix motherboards.

3. Attach the cable stoppers.

4. Screw the cable stoppers by using two screws removed in the step 2.
5. Install the cover.
