Modification Recommended Service Note

E36155A 800W Autoranging Benchtop Power Supply, 60V, 40A

Serial Numbers: MY62101001 - MY63001001

The Problem – ATTENTION – Firmware update to 1.1.14-1.0.1-1.16 and newer is mandatory for non-ATMU user only.

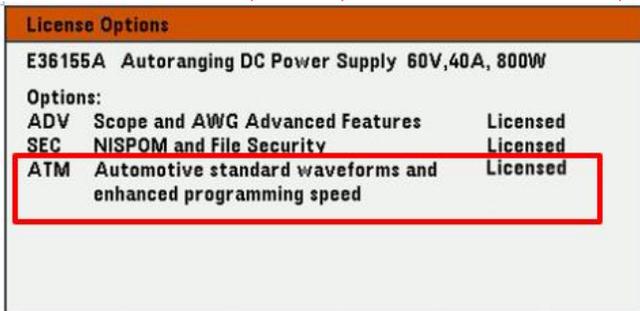
1. Check if the instrument is installed with ATMU option
At instrument front panel, go to:
[Utilities > Test/Setup > Help > About > License Options](#)

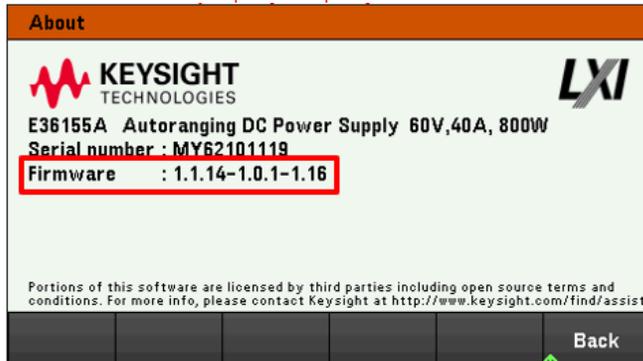
2. Check the instrument's firmware version.
At instrument front panel, go to:
[Utilities > Test/Setup > Help > About](#)

3. If the firmware version is **NOT 1.1.14-1.0.1-1.16 and newer**, please update the firmware.
4. Download the firmware file from:
<https://keysight.com/find/E36155A> > Visit Technical Support > Driver, Firmware & Software.
Detailed instructions for updating E36155A are available at Keysight.com.
