**E3640A-02**

**S E R V I C E N O T E**

**E3640A DC Power Supply**

**Difficulty to adjust the knob control on front panel due to encoder issue.**

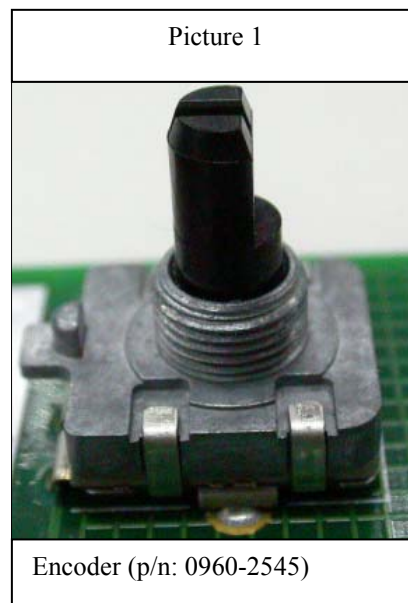
- 1) When turning the knob of the power supply, user will find it difficult to adjust to get the desired setting (example of difficulty – user need a few turns to increase just a step of voltage/current).
- 2) Some times, by turning the knob clockwise to increase the voltage and current setting, user will see a decrease in values.

- 1) If the unit is confirmed having the problem described above (after verification steps), continue with Step 2. Otherwise, no further action is required.
- 2) Remove encoder (reference designator – RE1) on the front panel display PCA. Replace with another encoder (refer to Picture 1 below).
