E3910A/B-02-S

S E R V I C E N O T E

HP E3910A/B PT500 Protocol Tester

Possible Shock Hazard

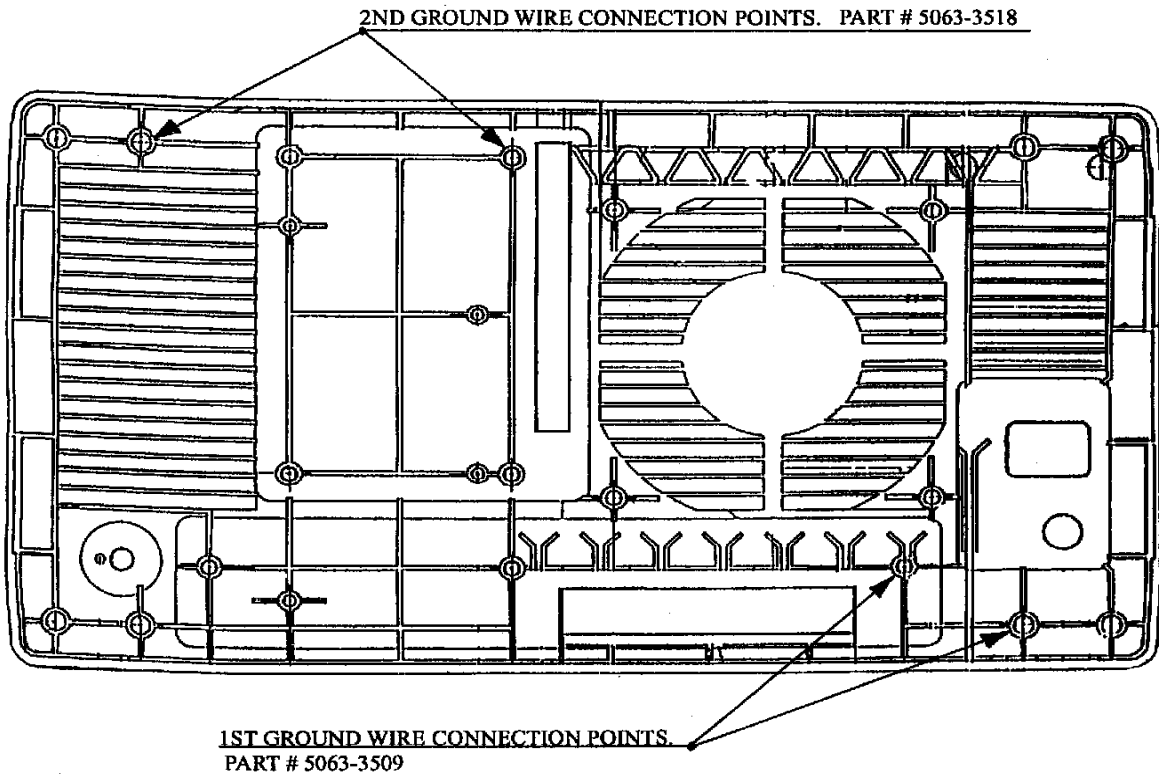
PT BACK BEZEL GROUNDING WIRES UPGRADE

High voltage applied to the connector module plane or connector module handle could cause the existing ground path to open, resulting in a possible shock hazard to the user.

A situation exists in which a unit in the referenced serial number range could possibly become a shock hazard to personnel. This situation would likely only occur if high voltage is present on the connector module plane or connector module handle and the existing ground path was blown away. The existing ground path is insufficient to carry current specified by Hewlett-Packard safety requirements. This situation has occurred to date only when checking the unit with a megger or similar device.

Affected units must be retrofitted with grounding wires to rectify the problem, using the following instructions.

- Remove top cover of instrument and interface module.
- Install longer (11 cm) ground cable, p/n 5063-3518, to existing screw of upper left hand side member bracket hole.
- Connect to inside connector module hole, beside degaussing board, with 4x5 screw.

- Remove bottom cover of instrument and auxilliary connector module.
- Install 8 cm ground cable, p/n 5063-3509, to right hand side hole of auxilliary connector with 4x5 screw.

- Connector module handle should be grounded from the rear handle screw to the nearest DB style connector screw by installing one of the 5063-3510 wires between these two points.
- Use the four 4x28 screws to reinstall connector module.

- Applies only to MPT368.2, IPT468, XPE systems with no parallel printer connector, that is, with auxilliary connector module 4010-0070-IDA.
- Install grounding wire between the handle mounting screw and the nearest screw of the "PRINTER" connector.
- Reinstall auxilliary connector module using three 4x25 screws.
