**E4350B-03**

# **S E R V I C E                      N O T E**

## **E4350B Solar Array Simulator**

### **Out of specification Peak to Peak Ripple & Noise at 20 kHz**

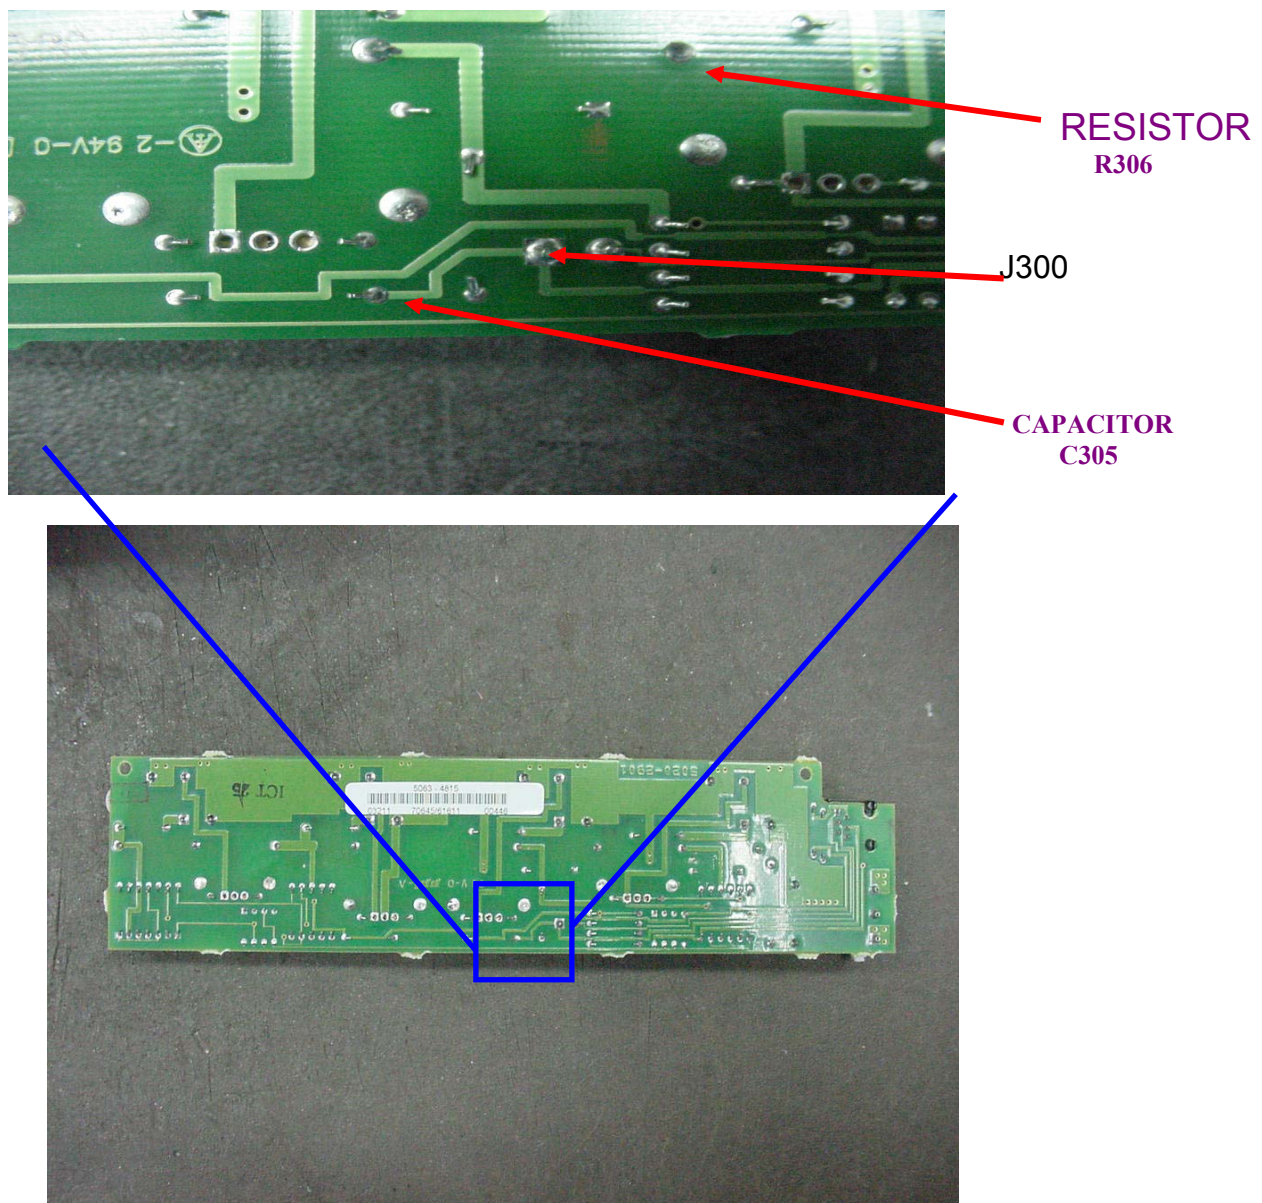
**1. Figure below showing right tunnel PCA P/N 5063-4815 board ready for rework.**

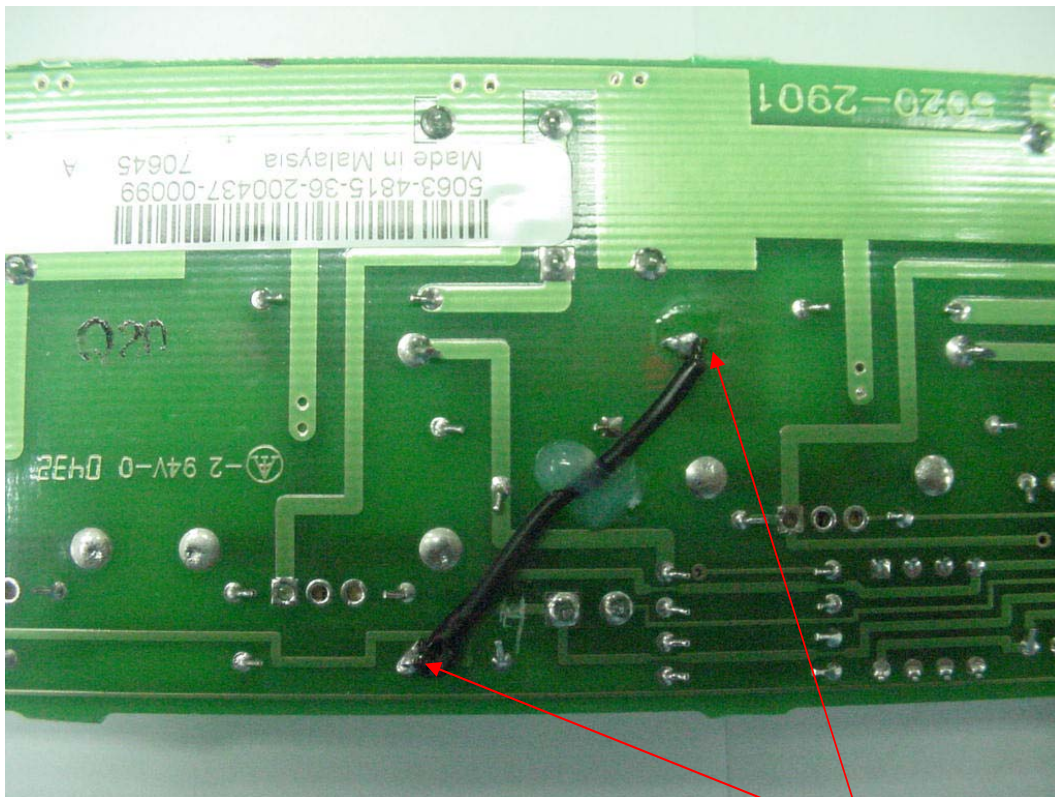
**GOOD SOLDER JOINT**

3. Figure below shows 22 AWG wire fully soldered to its place. **Add epoxy glue to hold the 22 AWG wire firmly in place. Make sure good solder forms at both end of 22 AWG wire.**
