**E4351B-04**

# **S E R V I C E N O T E**

## **E4351B Solar Array Simulator**

### **Out of specification Peak to Peak Ripple & Noise at 20 kHz**

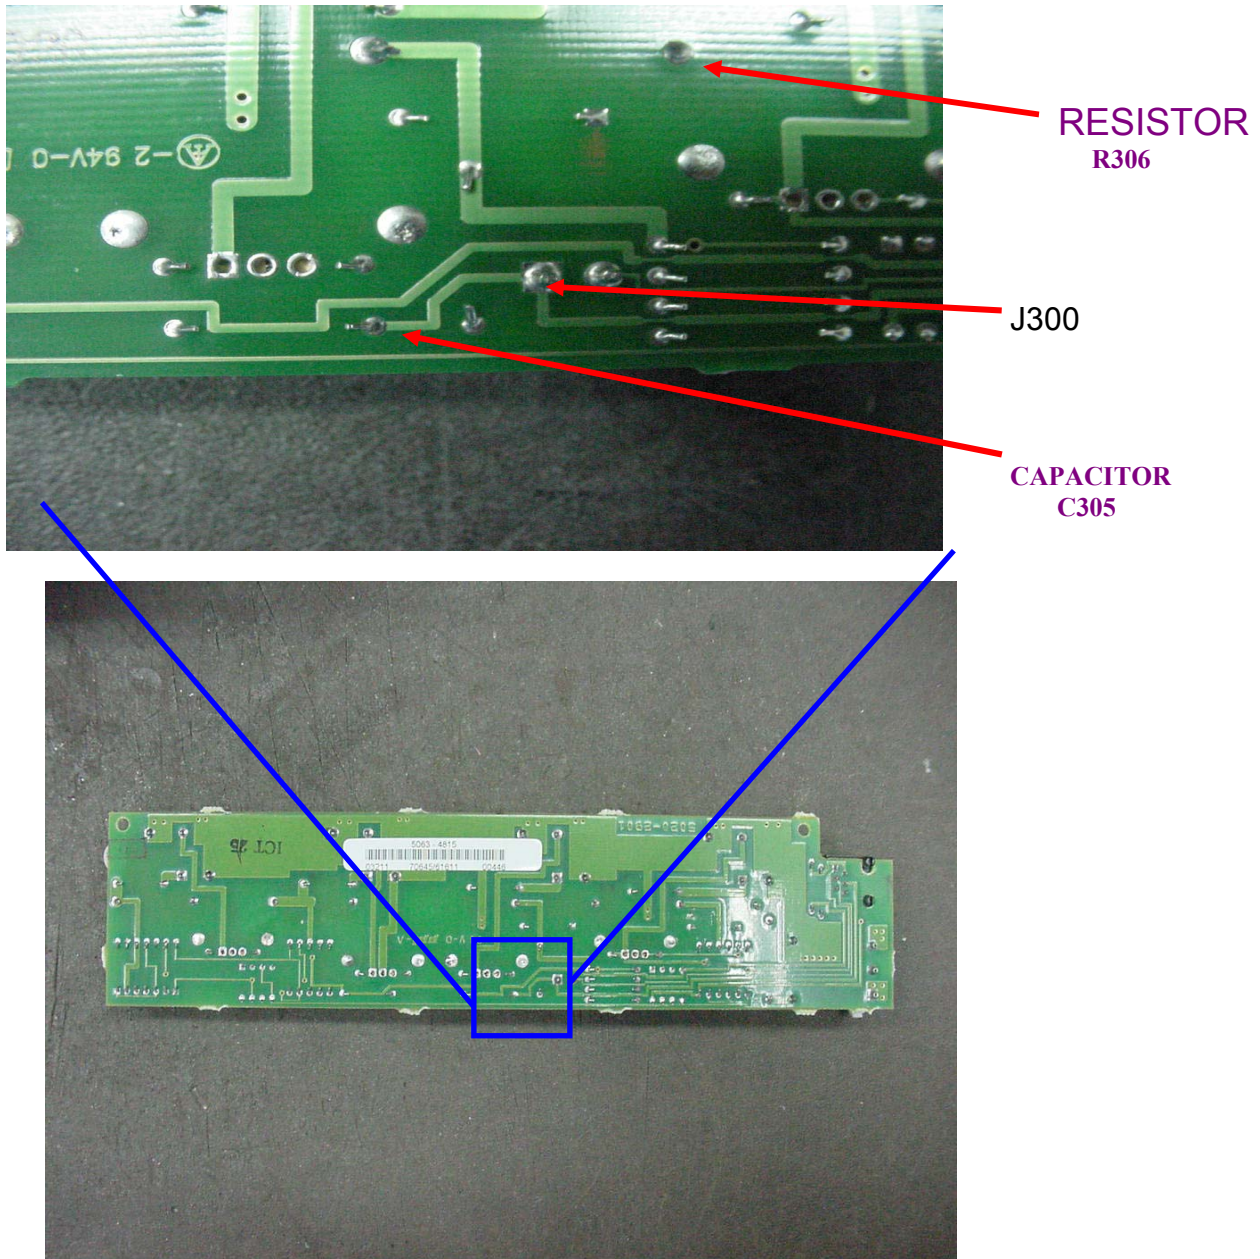
**1. Figure below showing right tunnel PCA P/N 5063-4815 board ready for rework.**

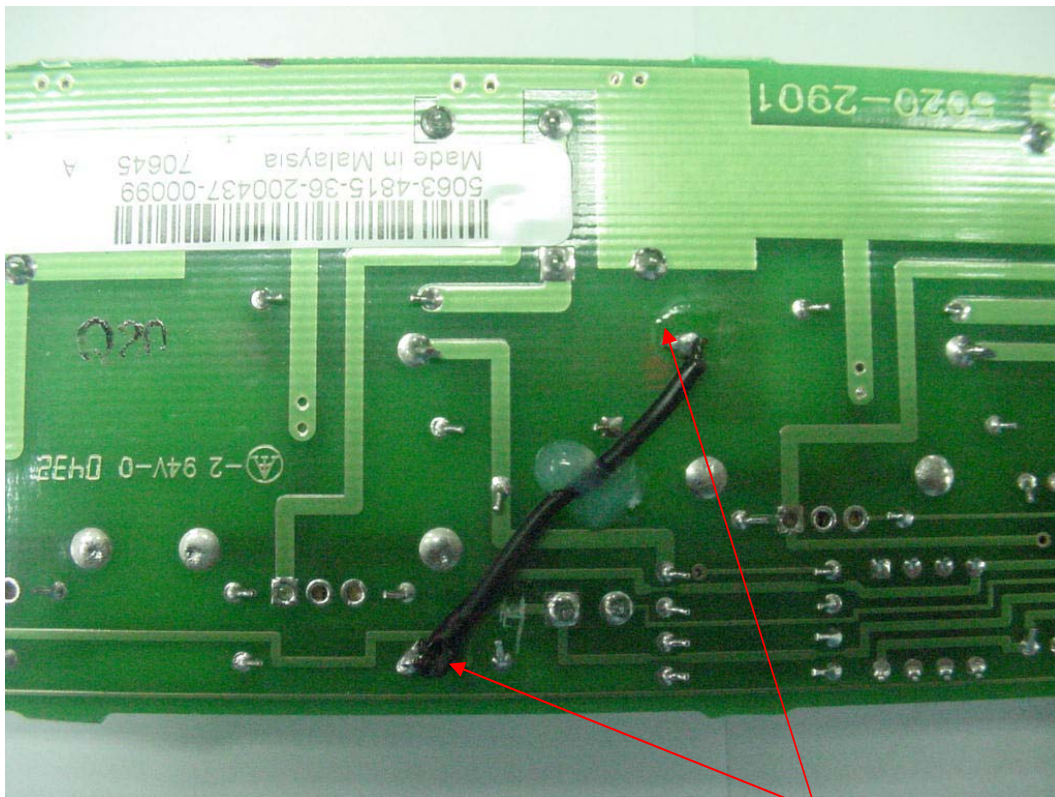
**GOOD SOLDER JOINT**

3. Figure below shows 22 AWG wire fully soldered to its place. **Add epoxy glue to hold the 22 AWG wire firmly in place. Make sure good solder forms at both end of 22 AWG wire.**
