E4403B-12

S E R V I C E N O T E

E4403B ESA Series Spectrum Analyzers

An error message occurs during the 3 GHz RF Assembly Adjustment portion of the TME LO Amplitude Adjustment test on the instruments which have certain vintages of the ESA RF assembly.

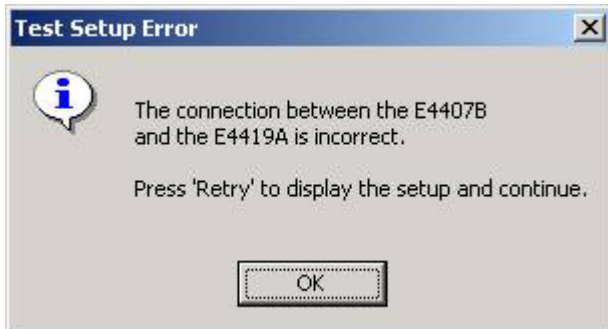
If the ESA being adjusted has a 50 ohm, 3 GHz input part number of E4403-60100 or E4403-60107, the 3 GHz RF Assembly Adjustment portion of the LO Amplitude Adjustment test will fail. The error message on the PC looks like:

The failure is occurring because a DAC was recently removed from the RF assembly board and replaced with a fixed gain amplifier.

Before doing the LO Amplitude adjustment, press [System], {More 1 of 3}, {Show Hardware} on your analyzer. Look for “50 ohm 3 GHz Input” assembly name. If the part number listed is E4403-60100 or E4403-60107, skip the 3 GHz RF Assembly LO Adjustment portion under the LO Amplitude Adjustment test. Perform all the other adjustments under the LO Amplitude Adjustment except this one.

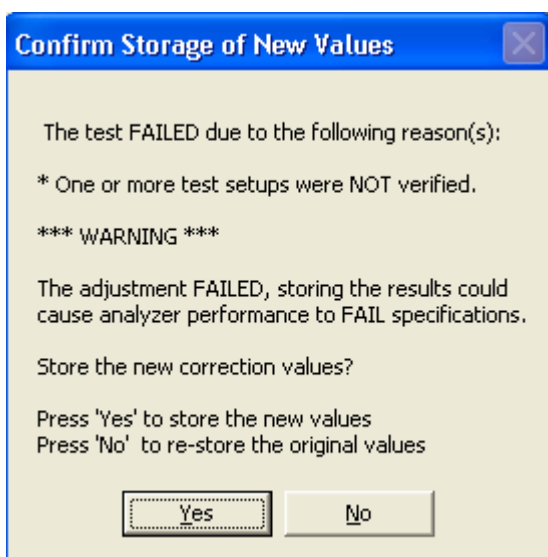
After all the portions except the 3 GHz RF Assembly LO Adjustment of the LO Amplitude Adjustment test are run, when you click on “Finish” Test, the following message appears on the screen.

This error message occurs because the 3 GHz RF Assembly Adjustment portion of the LO Amplitude Adjustment test was not performed. Click “Yes” to store the new values. After you click yes, the following message appears on the PC screen:
