E4404B-18

S E R V I C E N O T E

E4404B ESA Series Spectrum Analyzers

An error message occurs during the 3 GHz RF Assembly Adjustment portion of the TME LO Amplitude Adjustment test on the instruments which have certain vintages of the ESA RF assembly.

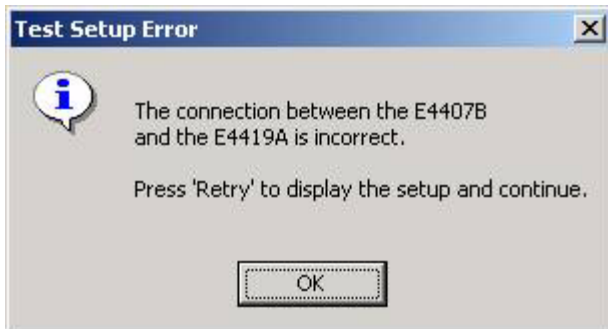
If the ESA being adjusted has a 50 ohm, 3 GHz input part number of E4403-60100 or E4403-60107, the 3 GHz RF Assembly Adjustment portion of the LO Amplitude Adjustment test will fail. The error message on the PC looks like:

The failure is occurring because a DAC was recently removed from the RF assembly board and replaced with a fixed gain amplifier.

Before doing the LO Amplitude adjustment, press [System], {More 1 of 3}, {Show Hardware} on your analyzer. Look for “50 ohm 3 GHz Input” assembly name. If the part number listed is E4403-60100 or E4403-60107, skip the 3 GHz RF Assembly LO Adjustment portion under the LO Amplitude Adjustment test. Perform all the other adjustments under the LO Amplitude Adjustment except this one.

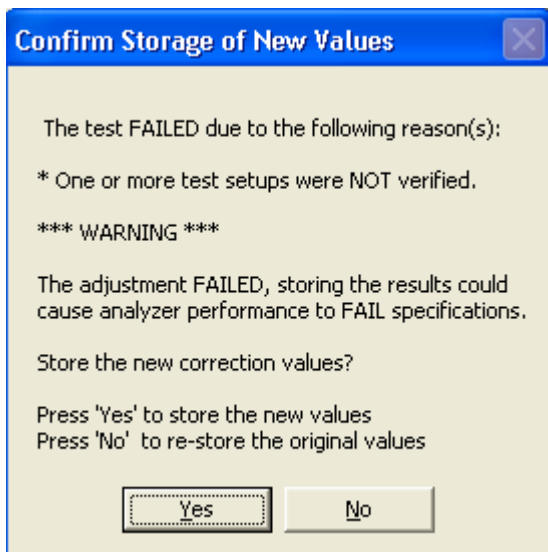
After all the portions except the 3 GHz RF Assembly LO Adjustment of the LO Amplitude Adjustment test are run, when you click on “Finish” Test, the following message appears on the screen.

This error message occurs because the 3 GHz RF Assembly Adjustment portion of the LO Amplitude Adjustment test was not performed. Click “Yes” to store the new values. After you click yes, the following message appears on the PC screen:

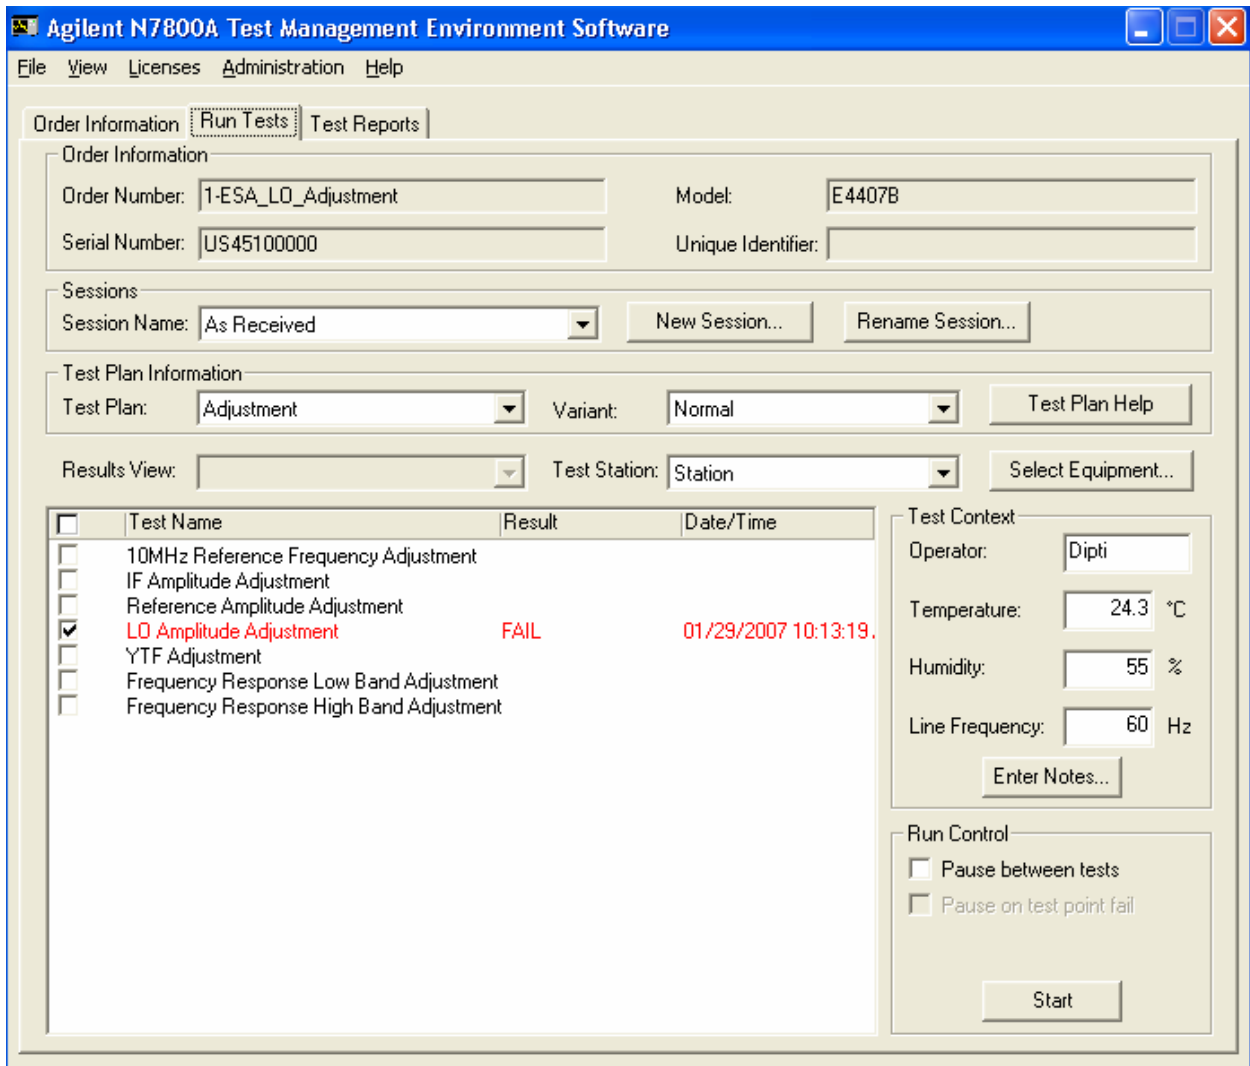
Click on "Run Next test" or just wait for 5 seconds, depending on the tests you are running. After 5 seconds or after all the other adjustment tests are performed, here is what the adjustment test result will look like:

The LO Amplitude adjustment test result appears as Fail because the 3 GHz RF Assembly Adjustment portion of the LO Amplitude Adjustment test was not performed. Ignore the fail message and continue with your tests.

The software engineering team is working on getting the TME software updated to remedy this situation. The updated version will be ready by July 2007. Check your TME software for updates during that time frame.
