E4417A-12A

S E R V I C E N O T E

Agilent E4417A EPM-P Peak & Average Power Meter

Front Panel Display Problems Caused by Power Assembly Cable

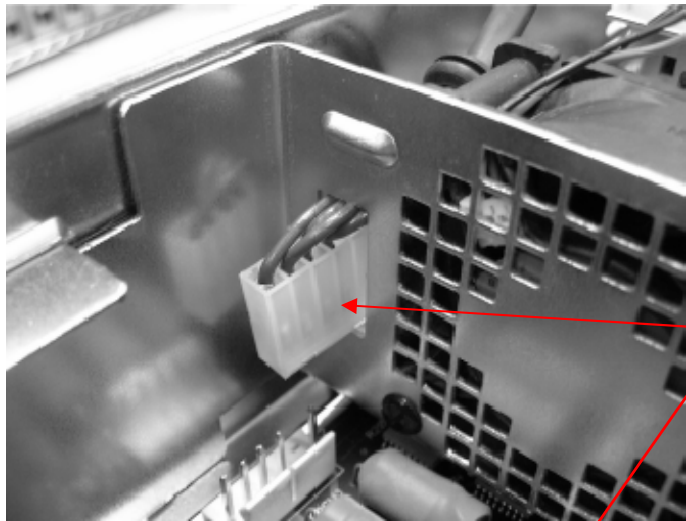
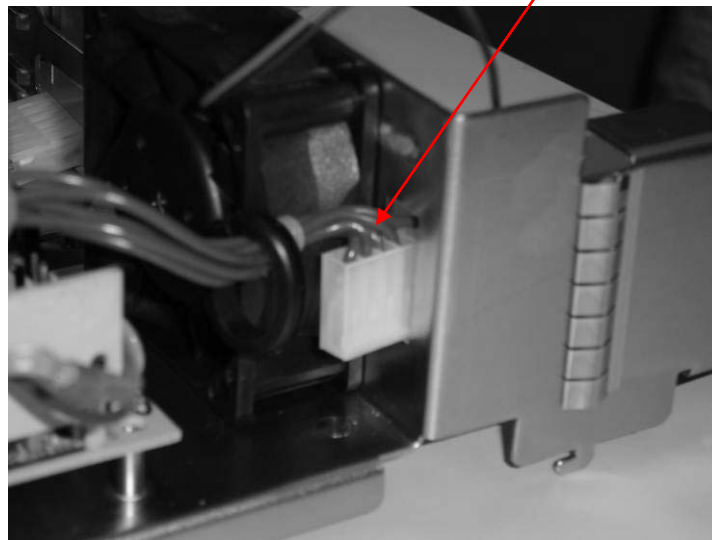
Insert the plastic casing horizontally

- 5) Here are some tips regarding the new cable. Since the plastic casing is slightly bigger in size, so you cannot directly pass through connector through hole. So you need to insert the cable horizontally. See illustration below.

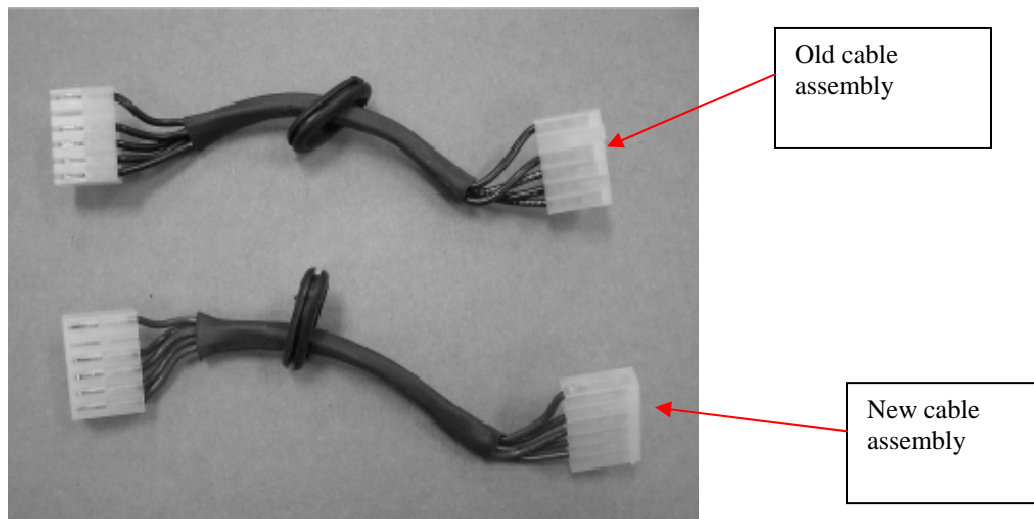
- 6) Photo below show different of old and new cable. The new cable is red in color whereas the old cable is black in color.

Note: If the power cable assembly is red in color, indicates that the cable already been changed. No action is needed.
