E4419B-04A

SERVICE NOTE

Agilent E4419B EPM Average Power Meter

Remove & Refit Outer Cover To Fix EMI Gasket Issues

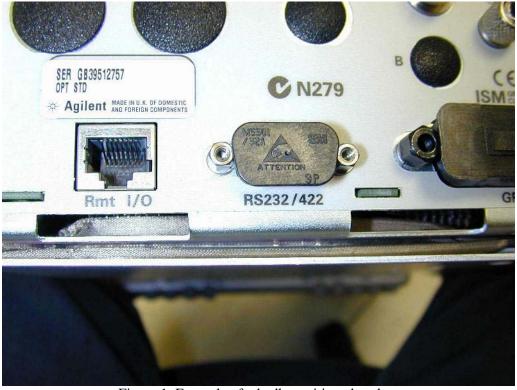
The units with serial numbers above may have a badly positioned EMI Gasket. The first indication of the problem would be via a visual inspection, where the conductive EMI Gasket may be seen to be in contact with the underside of the Comms Assembly (A4). The inspection procedure is shown in the next section. Where the gasket position is causing the unit to fail, the failure mode is uncertain, as this will depend on the area of the board it is touching. The following failure modes have been encountered so far:

- * Instrument will not power up after the Hi-Pot insulation test.
- * RS422/RS232 self-test failure.

Figure 1. Example of a badly positioned gasket.

- 1. Remove the Rear Bezel and inspect the gasket to see if it is encroaching on the Comms Assembly. See Figure 1 below for an example of a badly positioned gasket.
- 2. If the gasket is not positioned correctly, slide off the Outer Cover and then slide it back on again. As the gasket is part of the Outer Cover Assembly, this action will put it back into the correct position.
- 3. Inspect the gasket to make sure it is now positioned correctly. Verify that all the Built In Self Test tests pass.
