E4440A-20

**S E R V I C E N O T E**

E4440A - PSA Series Spectrum Analyzer

**Internal Alignment Failures for PSA Series Spectrum Analyzers Manufactured Between January 2004 and February 2006 Caused by Low Power Output from A9A1 DRO on A9 Second LO Assembly**

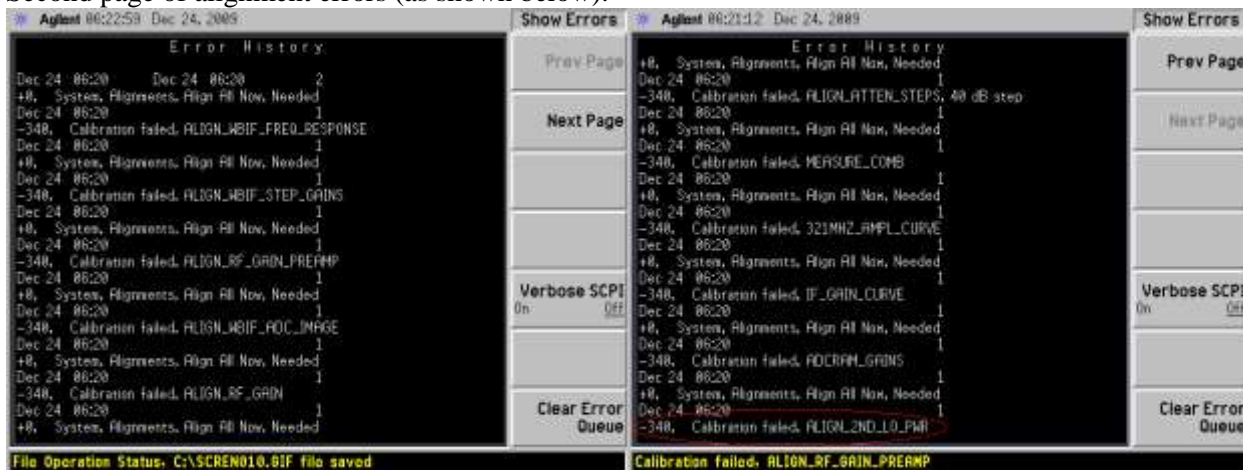
Verify the alignment failure by looking at the error queue for the error message “-340, Calibration failed, Align\_2<sup>ND</sup>\_LO\_PWR”. Press [System] <Show Errors> <Next Page>. Typically, when the Second LO power is too low, it will be the first failure listed in the alignment queue, which will be at the bottom the Second page of alignment errors (as shown below):

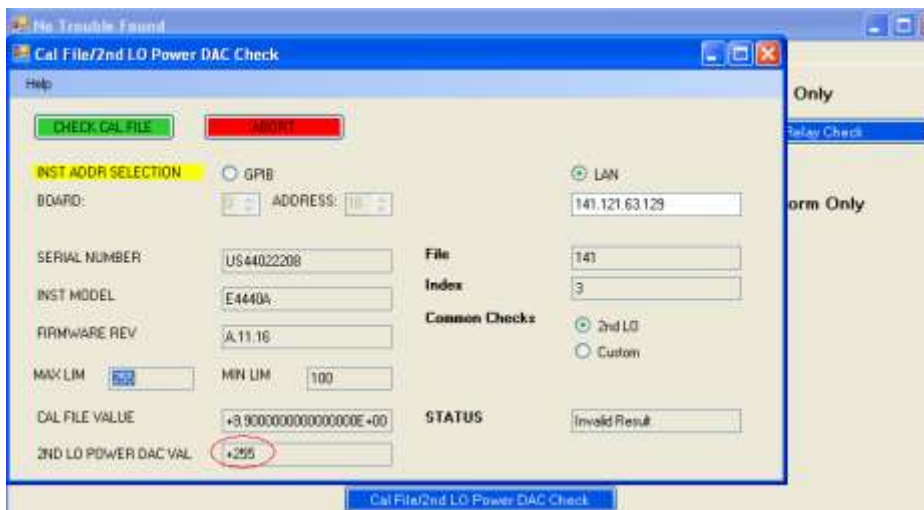
A value of +255 for the Second LO Power DAC Val will be returned if the analyzer is not able to set enough gain to the Second LO amplifier on the A20 low band assembly if the DRO power output is too low. The lower the DAC value reported is, the more gain the low band amplifier is using. When the low band amplifier is no longer able to provide enough gain, the DAC value rolls from 0 (most gain) to 255 (least gain), causing the internal alignments to fail.

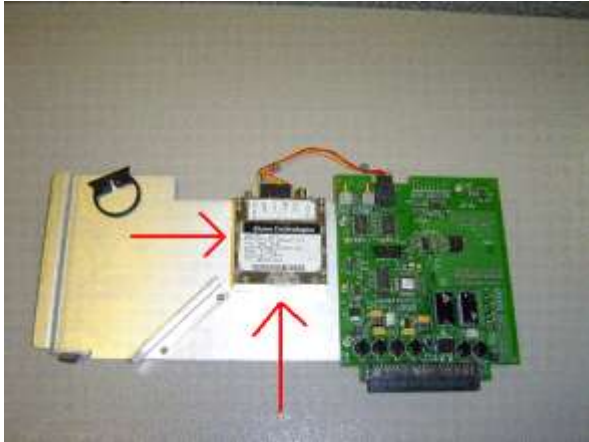
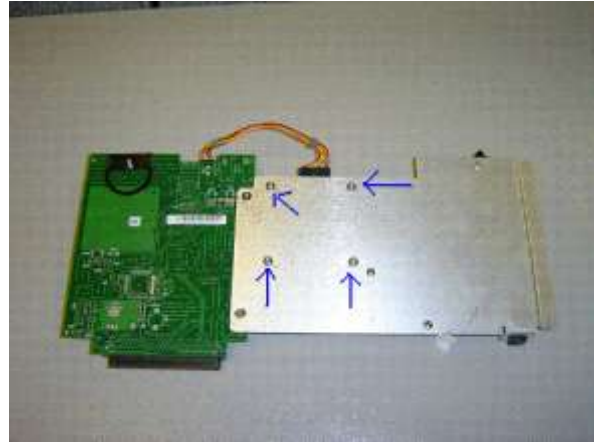
The failure can further be verified by directly measuring the power output from the A9A1 DRO on the A9 Second LO assembly. The instrument cover and top brace must be removed and the instrument powered up. The W15 cable connected to the Second LO must first be disconnected. Either a spectrum analyzer or power meter can be connected to the 3.6 GHz output of the Second LO to measure the power output level. New DRO's typically output +1 to +3 dBm of power; however, any output power above -2 dBm is normal. Whenever the power output is less than -5 dBm, the DRO is bad, and the amplifier on the A20 low band assembly is no longer able to compensate.

Replace just the DRO by removing it from the Second LO assembly and replacing it with a new one.

No adjustments are needed, since the Second LO Power Adjustment routine in the TME calibration software is only necessary to be run when the A20 low band assembly is replaced and not when the DRO or Second LO assembly is replaced.
