E4443A-19 <u>S E R V I C E N O T E</u>

E4443A - PSA Series Spectrum Analyzer

Internal Alignment Failures for PSA Series Spectrum Analyzers Manufactured Between January 2004 and February 2006 Caused by Low Power Output from A9A1 DRO on A9 Second LO Assembly

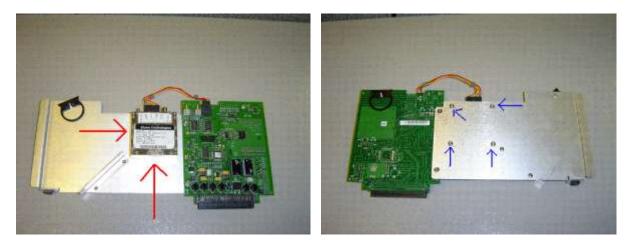
The failure can further be verified by directly measuring the power output from the A9A1 DRO on the A9 Second LO assembly. The instrument cover and top brace must be removed and the instrument powered up. The W15 cable connected to the Second LO must first be disconnected. Either a spectrum analyzer or power meter can be connected to the 3.6 GHz output of the Second LO to measure the power output level. New DRO's typically output +1 to +3 dBm of power; however, any output power above -2 dBm is normal. Whenever the power output is less than -5 dBm, the DRO is bad, and the amplifier on the A20 low band assembly is no longer able to compensate.

Replace just the DRO by removing it from the Second LO assembly and replacing it with a new one.

No adjustments are needed, since the Second LO Power Adjustment routine in the TME calibration software is only necessary to be run when the A20 low band assembly is replaced and not when the DRO or Second LO assembly is replaced.
