E4445A-19 <u>S E R V I C E N O T E</u>

E4445A - PSA Series Spectrum Analyzer

Internal Alignment Failures for PSA Series Spectrum Analyzers Manufactured Between January 2004 and February 2006 Caused by Low Power Output from A9A1 DRO on A9 Second LO Assembly

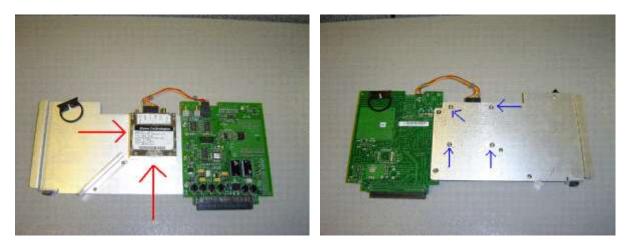
The failure can further be verified by directly measuring the power output from the A9A1 DRO on the A9 Second LO assembly. The instrument cover and top brace must be removed and the instrument powered up. The W15 cable connected to the Second LO must first be disconnected. Either a spectrum analyzer or power meter can be connected to the 3.6 GHz output of the Second LO to measure the power output level. New DRO's typically output +1 to +3 dBm of power; however, any output power above -2 dBm is normal. Whenever the power output is less than -5 dBm, the DRO is bad, and the amplifier on the A20 low band assembly is no longer able to compensate.

Replace just the DRO by removing it from the Second LO assembly and replacing it with a new one.

No adjustments are needed, since the Second LO Power Adjustment routine in the TME calibration software is only necessary to be run when the A20 low band assembly is replaced and not when the DRO or Second LO assembly is replaced.
