## E4981A-06

# S E R V I C E N O T E

E4981A Capacitance Meter, 120/ 1 kHz/ 1MHz

**Overload error occurs while Autor-anging with low temperature**

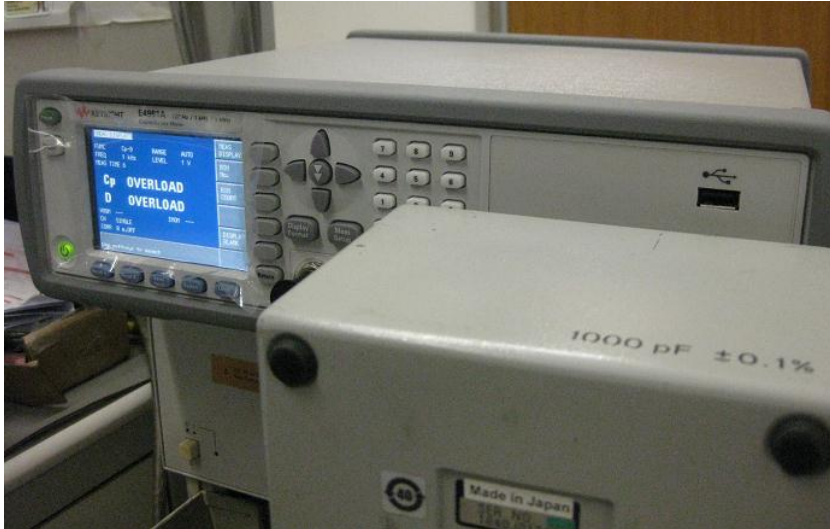
Overload error frequently occurs while Auto-ranging with low temperature (equal or below 5 degrees Celsius) at customer site. This symptom might not be reproduced with normal temperature at Keysight service center.

When service center receives this complaint from a customer, replace the analog board with a brand new analog board though it's not reproduced by the service center. This action is to prevent from reoccurrence of the same symptom at customer site after No Trouble Found (NTF) return.
