E5062A-04A

SERVICE NOTE

E5062A ENA-L RF Network Analyzer, 300 kHz to 3 GHz

A2 receiver board fails System Dynamic Range specification due to a very few clock signal generation component might not work properly.

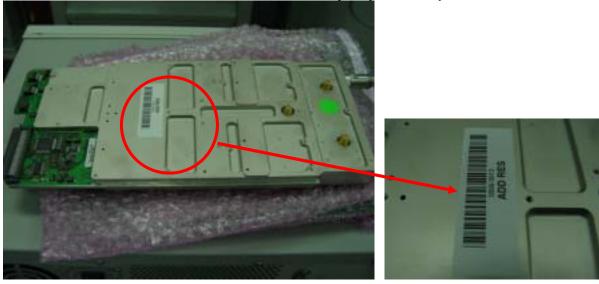
Any of these three cases are "good" A2 receiver module, otherwise return the "bad" module to factory through exchange program.

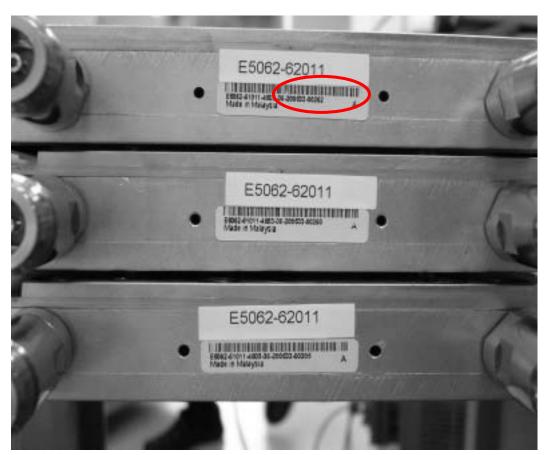
(2) A2 Receiver Module with BARCODE which date code suffix is -200607-xxxxx or later (Temporary solution by CM)

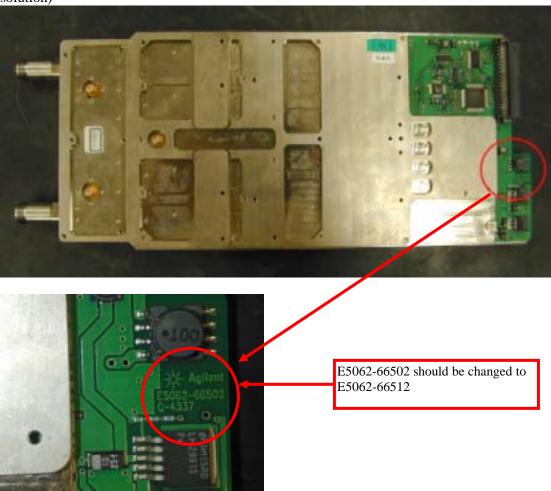
(3) PCA in A2 Receiver Module is changed from E5062-66502 to **E5062-66512.** (Permanent solution)
