# E5070B-14

# S E R V I C E N O T E

E5070B ENA Series Network Analyzer, 300 kHz to 3 GHz

**Firmware update is failed with CP300 HDD image, while updating firmware to FW Rev.A.08.00 or later**

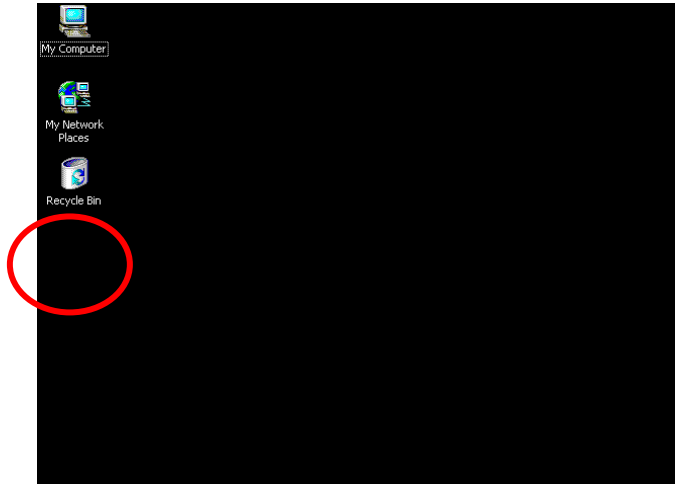
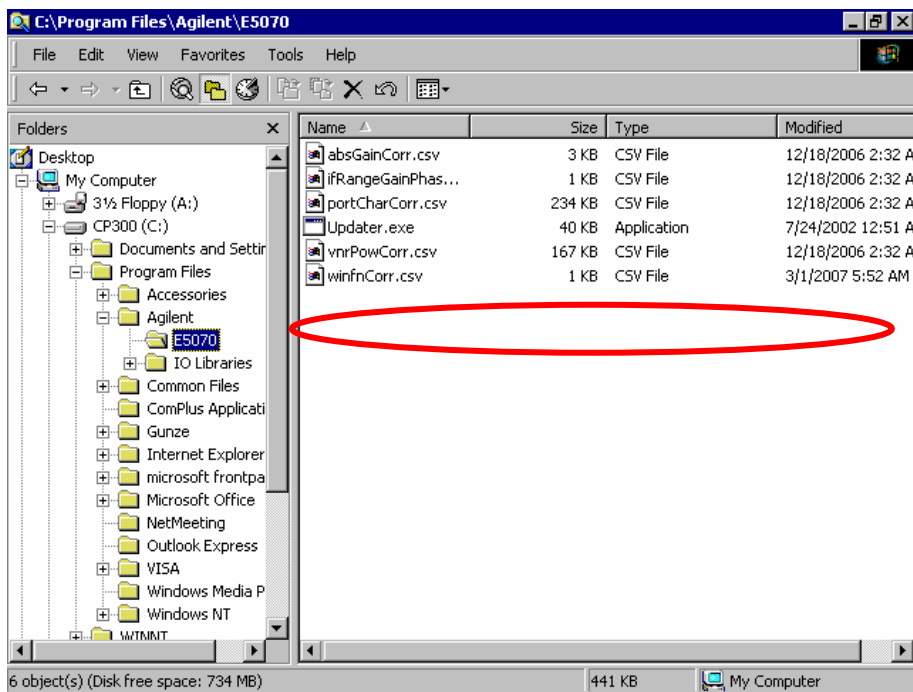
If a customer updates the firmware to FW Rev.A.08.00 or later with CP300 HDD image, firmware update is failed and most of the firmware files are deleted.

Network Analyzer shortcut on the Desktop, E5070.exe on the \Program Files\Agilent\E5070 directory are deleted.

If yes, replace the A27 HDD referring to the E5070B/E5071B service manual chapter 5, 6 & 7.

If no, perform System Recovery referring to the E5070B/E5071B service manual chapter B.

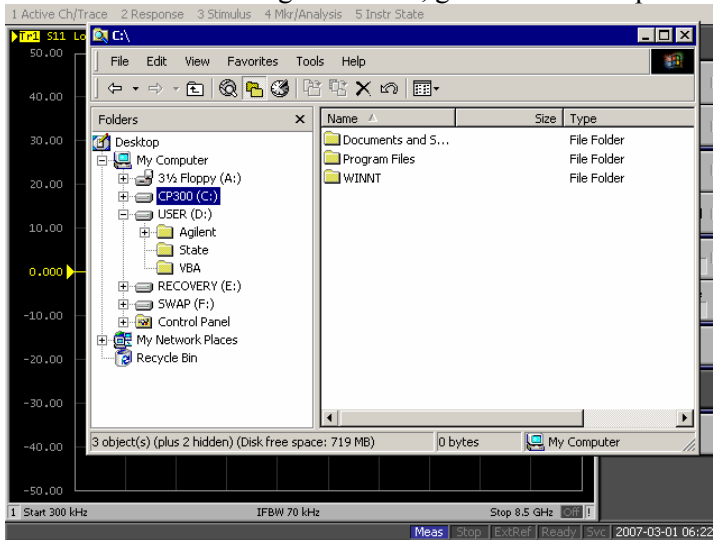
Step1. Check whether the HDD image revision is CP300 or not.

If the HDD image is CP300, go to the next step.

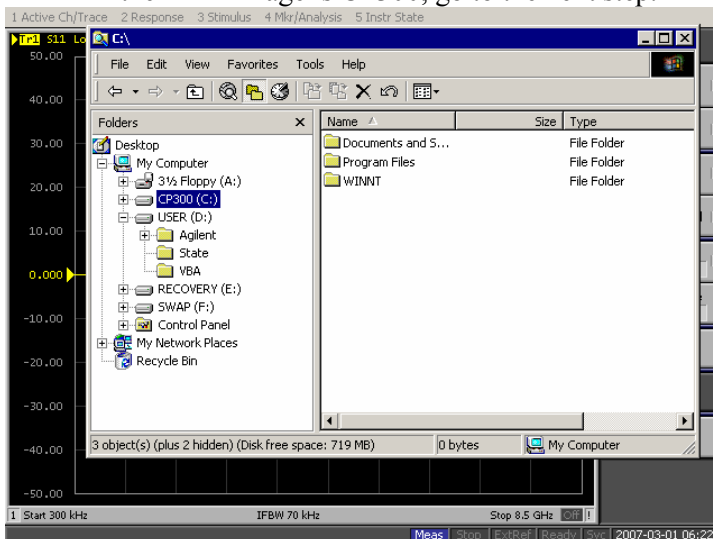
Step1. Check whether the HDD image revision is CP300 or not.

If the HDD image is CP300, go to the next step.

Step2. Replace the A27 HDD referring to the E5070B/E5071B service manual chapter 5, 6 and 7.
