E5071B-17

SERVICE NOTE

E5071B - ENA Series Network Analyzer, 300 kHz to 8.5 GHz

"To strengthen the front USB receptacle, add USB receptacle retention plate"

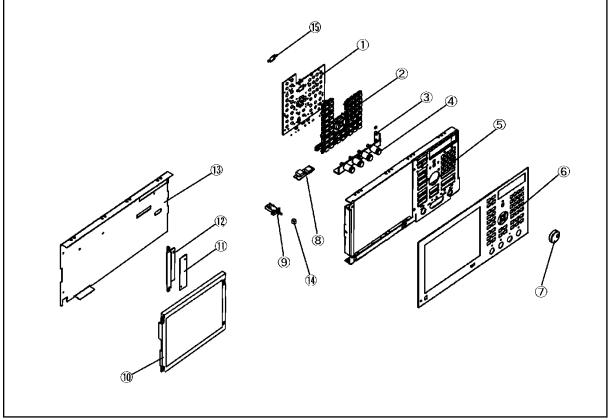
In case the front USB receptacle (E5070-66533) becomes loose, add USB receptacle retention plate (E5062-04003) to strengthen the front USB receptacle.

- e5070bse3007
- 1. Remove three pieces of screws. (See Reference Designator #8 of Figure 5-31 and Table 5-31 in the service manual)
- 2. Add USB receptacle retention plate.
- 3. Add the removed screws (See Reference Designator #8 of Figure 5-31 and Table 5-31 in the service manual) with 9 in-lb torque driver/T10 bit
