E5071C-13A

S E R V I C E N O T E

E5071C – ENA Series Network Analyzer, 9 kHz to 20 GHz

Step Attenuator Replacement Procedure

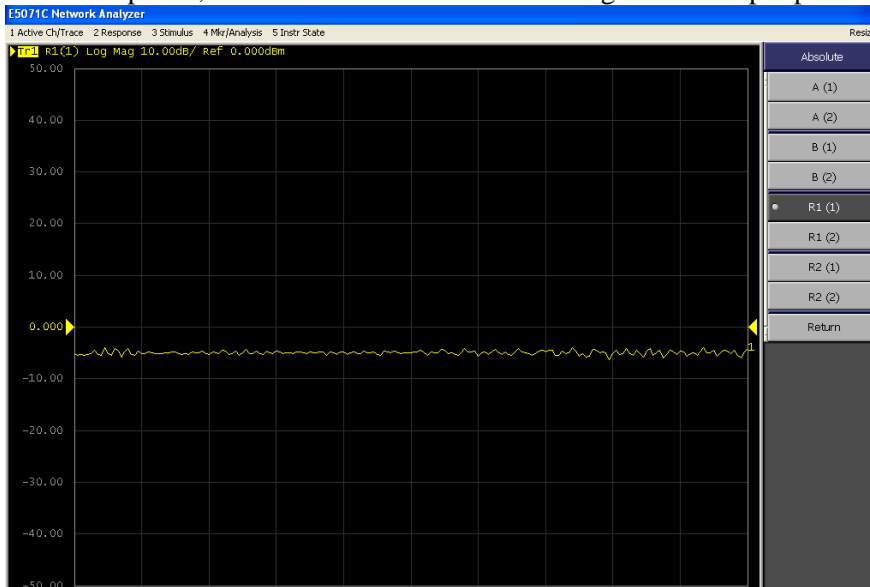
Good unit:

After unit preset, Absolute measurement is showing correct output power (-5 dBm)

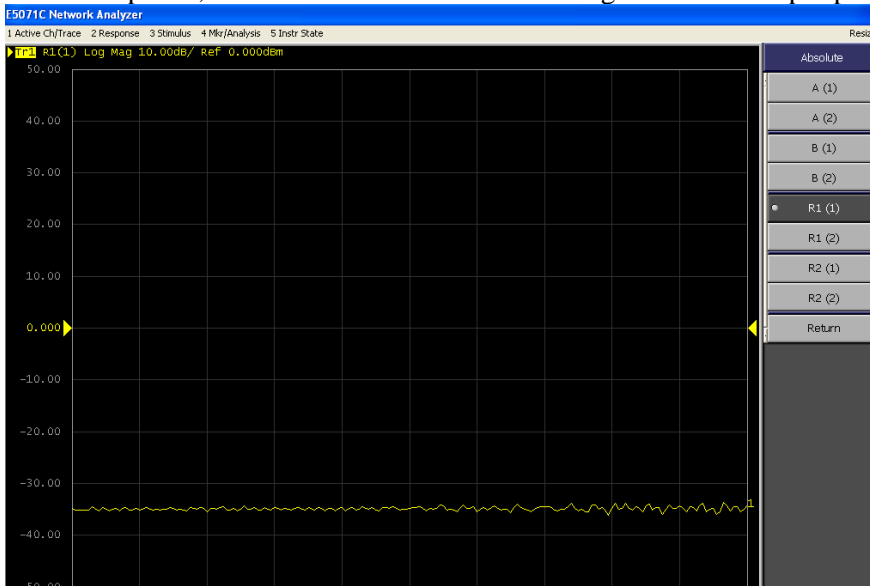
**Defective unit:**

1. Due to Step Attenuator failure, RF Output power level (Over 8.5GHz option) is inaccurate (decreased).
2. After preset, absolute measurement R1(1) , R2(2), R3(3) and R4(4) of the unit is reduced to ~-35dBm.

After unit preset, Absolute measurement is showing inaccurate output power (-35 dBm)

1. Replace the Step attenuator module according to part replacement procedure shown on service guide for Over 8.5 GHz Option. Use **33321-60082** when **33321-60065** is broken.
