E5071C-28B

Information Only Service Note

E5071C ENA Series Network Analyzer, 9kHz to 20GHz

Automatically shut down after a few seconds beeping occurs when user turns on the instrument

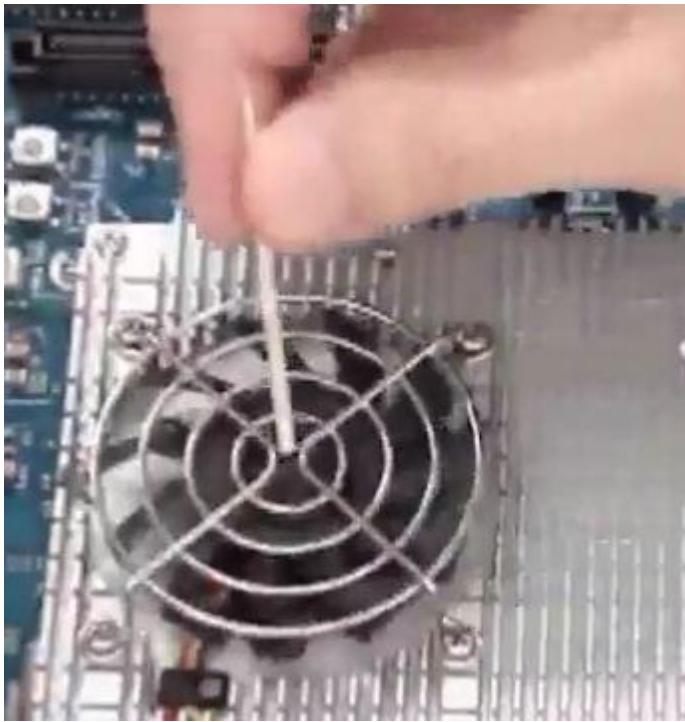
1. Push down CPU fan's rotor using something like tooth pick just after turning on power switch.

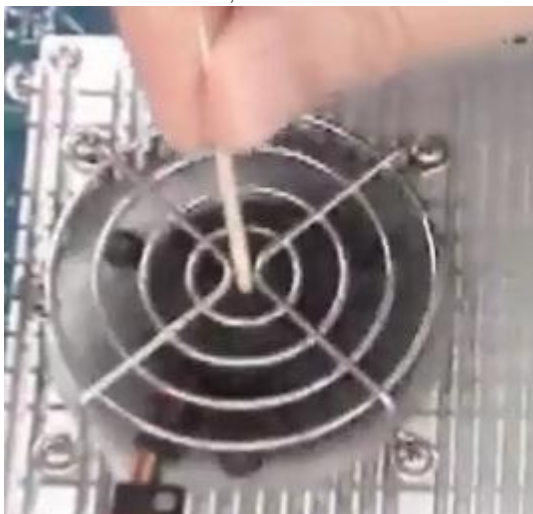
2. If CPU fan rotates, then the cause of the trouble is [dropped off rotor]

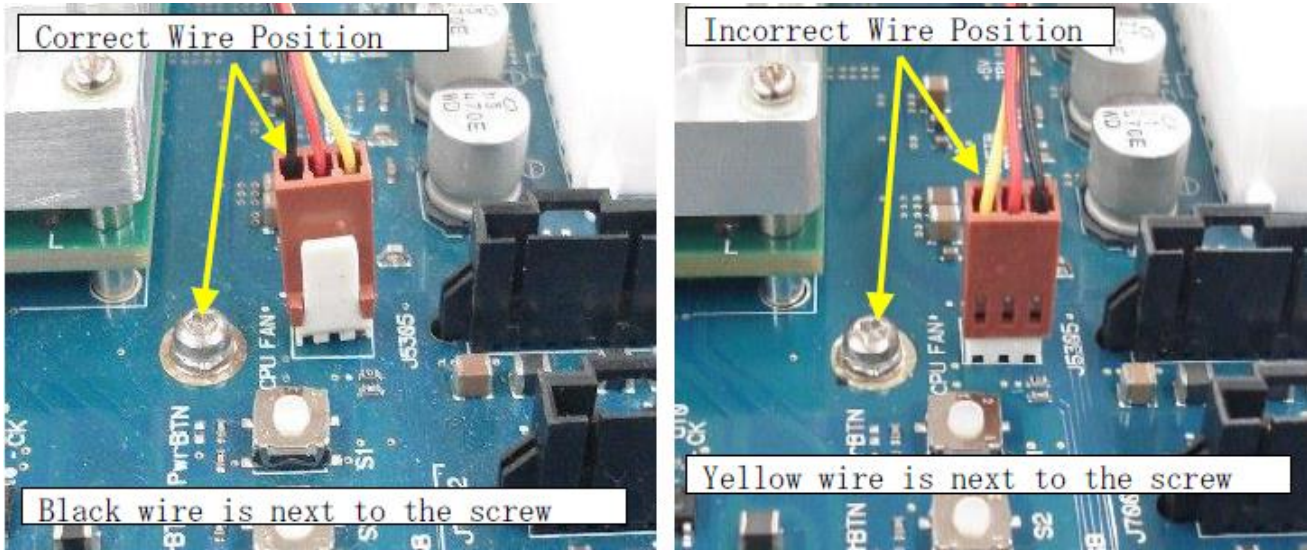
2-1 Check whether connector post (J19) for the CPU fan's interface cable is the correct direction or the opposite (incorrect) direction as shown below.

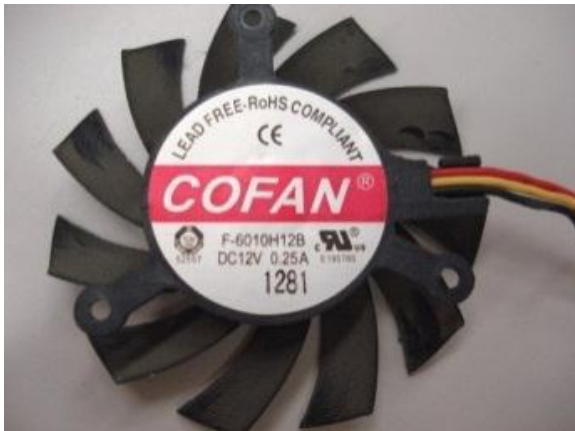
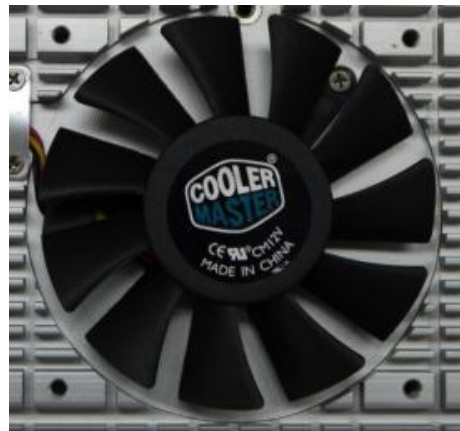
2-2 If black wire of the CPU fan cable is next to the nearby screw, J19 is assembled in a correct way.

2-2-1. If CPU fan is COFAN, replace CPU fan with 3160-4452 for repair.

2-2-2. If CPU fan is COOLER MASTER, replace CPU fan with 3160-4518 for repair.

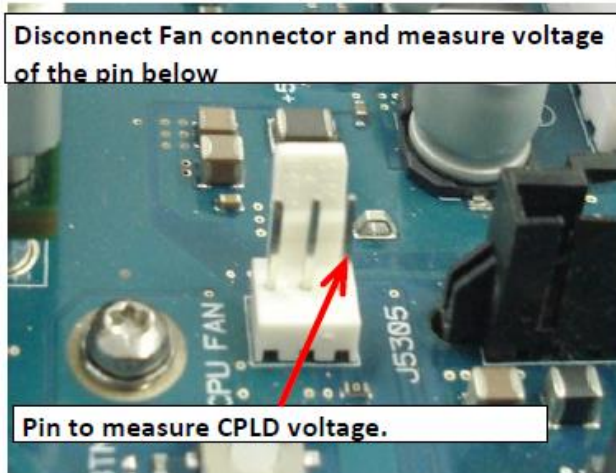
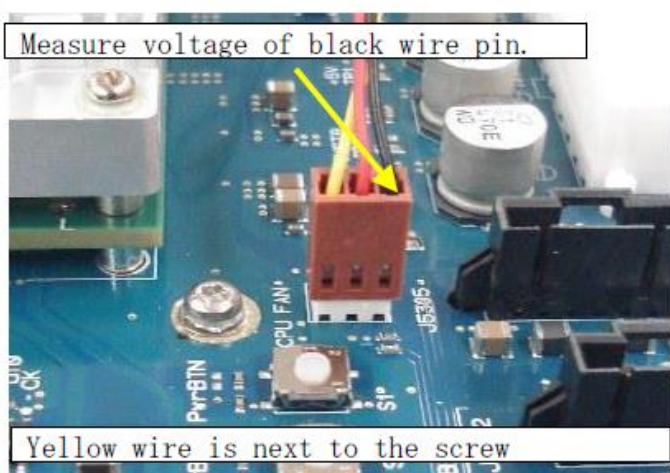
2-3 If yellow wire of the CPU fan cable is next to the nearby screw, J19 is assembled in an incorrect way. In this case, disconnect the CPU fan cable from J19 and measure CPLD voltage of the pin.

2-3-1. If the voltage is less than 1.2V, CPLD circuit of the CPU carrier board is damaged. In this case, replace whole CPU assembly with E5052-62070.

2-3-2. If the voltage is greater than 1.5V, the circuit of the CPU carrier board is OK.

2-3-2-1. If CPU fan is COFAN, replace CPU fan interface cable with 3160-4452 and E5071-61680.

2-3-2-2. If CPU fan is COOLER MASTER, replace the CPU fan with 3160-4518.
