E5071C-55

Information Only Service Note

E5071C ENA Series Network Analyzer, 9kHz to 20GHz

E5071C Touch Panel Controller & Solid State Drive compatibility reference

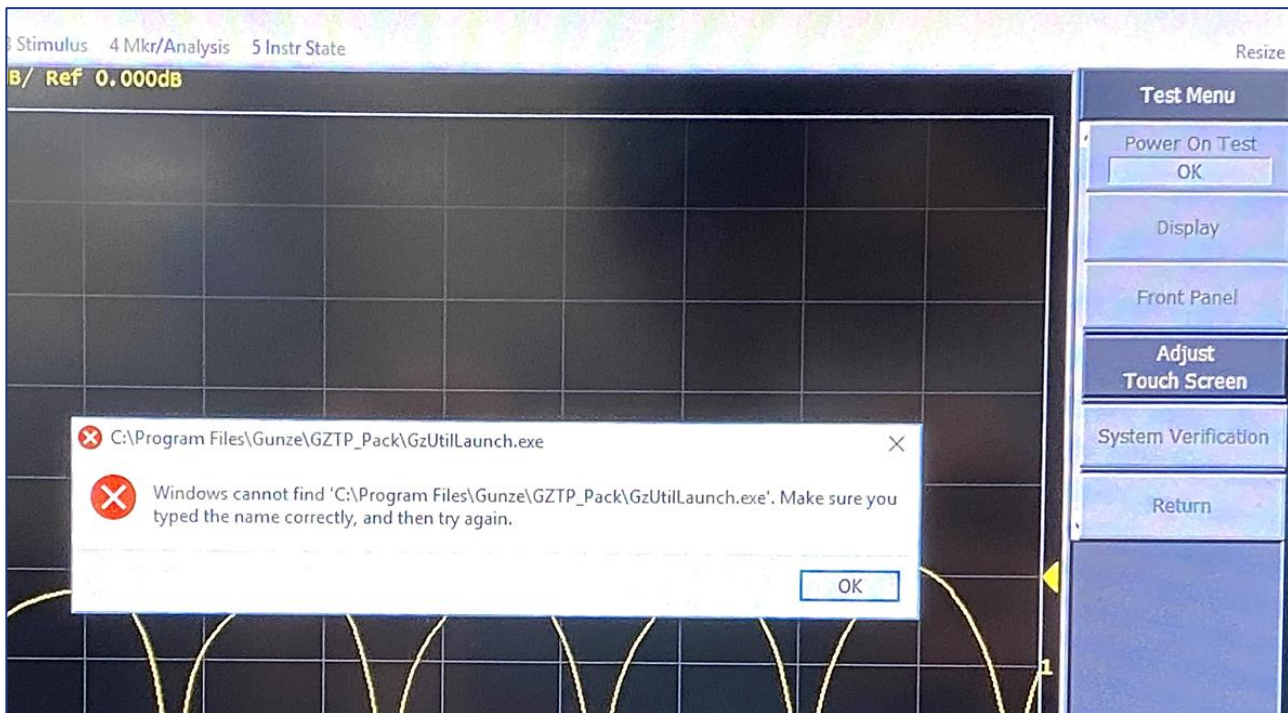
Incorrect combination of Touch panel and SSD will either result in unsupported touch panel controller or unexpected response to user touch inputs. The following error message will be prompted whenever user click on the “Adjust Touch Screen” function.

“Windows cannot find “C:\Program Files\Gunze\GZTP_Pack\GzUtilaunch.exe”. Make sure you typed the name correctly, and then try again.”

The solution to this is to either replace a brand new unused SSD or to repair as-is with the identical generation touch panel controller board.

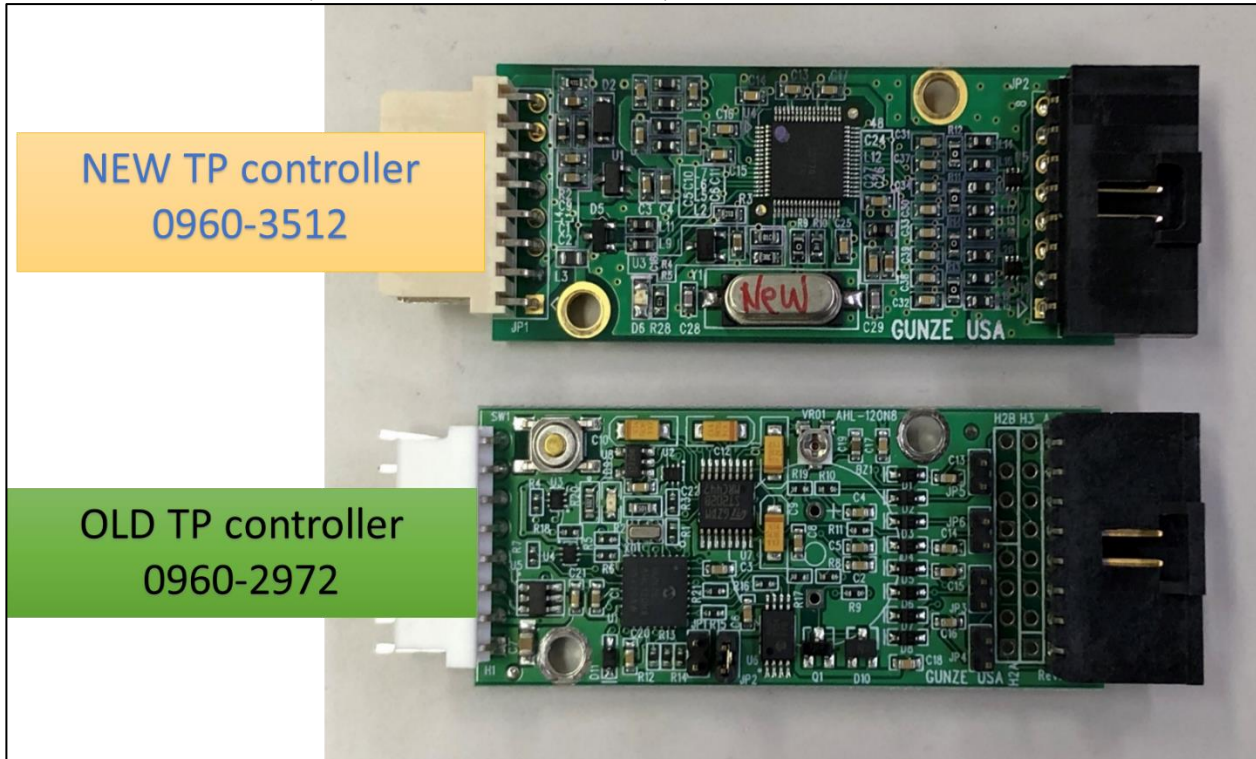
New touch panel controller is not a drop-in replacement and can only be supported by the identified SSD storage image (FW revision) or newer.

Shown is the visual comparison of old vs new touch panel controller.

1. For Official Win-10 with MY470/ SG470 serial number prefix and above, replace with **new** touch panel controller 0960-3512. This generation SSD supports the new touch panel since day-1.
2. For Official Win-10 with MY467/8/9, SG467/8/9 serial number prefix fitted with **new** touch panel controller, replace with **new** touch panel controller 0960-3512. This covers the Win-10 based E5071C which had its touch panel controller replaced along with the port or freq. upgrade conversion.
3. For Official Win-10 with MY467/8/9, SG467/8/9 fitted with **old** touch panel controller, replace with **old** touch panel controller 0960-2972.
4. For Win-10 E5071C upgraded from earlier Win-XP/ 7 generations (sn prefix of MY461-466,SG461-466) fitted with **old** touch panel controller, replace with **old** touch panel controller 0960-2972.
