E5091A-03

S E R V I C E N O T E

Agilent E5091A Multiport Test Set

SW2 Coaxial Switch part number change

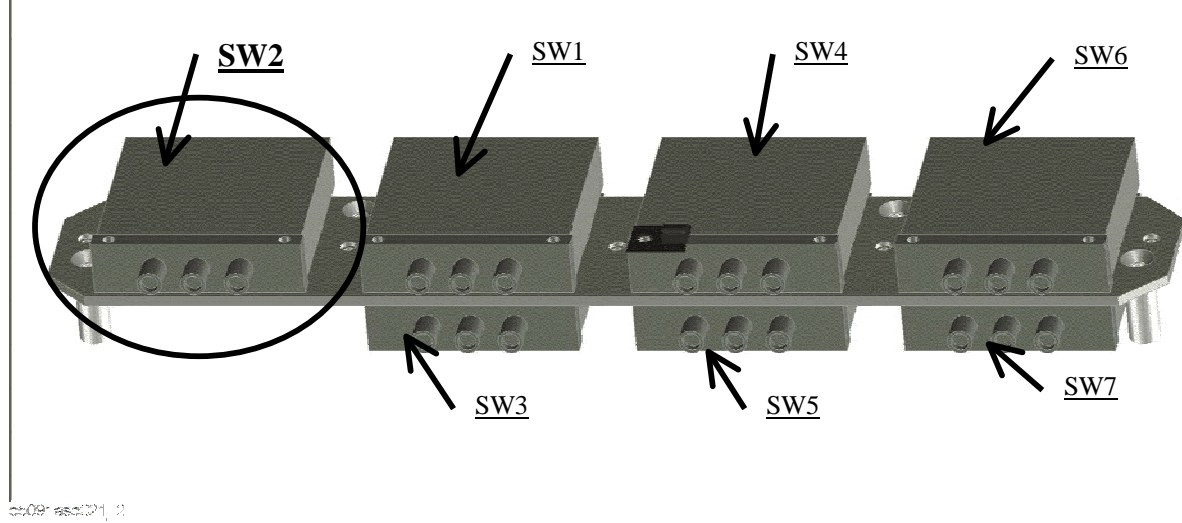
Opt. 009

The coaxial switch that is used for SW2 of the E5091A was changed from 5087-7137 to 5087-7272 to improve an input voltage tolerance. Switches parts were used as follows:

Use a newer part 5087-7272 when replacing SW2. Refer to following figures about the SW2 position.
